<b>Subject:</b> <b>PASSENGER SEAT BELT AND PASS AIRBAG OFF INDICATOR LIGHTS ON AND / OR SEAT WARMER STAYS ON AFTER WINDSHIELD TINT INSTALL</b>	<b>M-Tips No.:</b> MT-018/17
	<b>Last Issued:</b> 11/09/2017

2017 CX-5

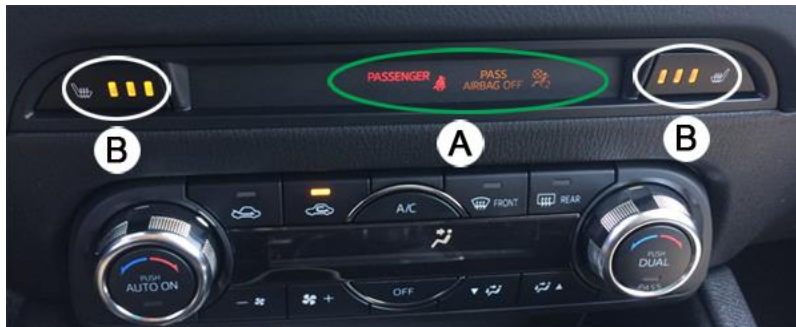
- PASSENGER Seat Belt and PASS AIRBAG OFF indicator lights ON (A).
- Front seat warmers ON (B) and cannot be turned OFF.

No DTC's are stored in memory. This may be caused by water contamination at connector C-56 after a recent aftermarket windshield tint installation.

1. Verify customer concern.
2. Inspect connector C-56 for water or corrosion.
3. Clean the connector.

**Note:** If cleaning is not possible, replace the wiring harness.

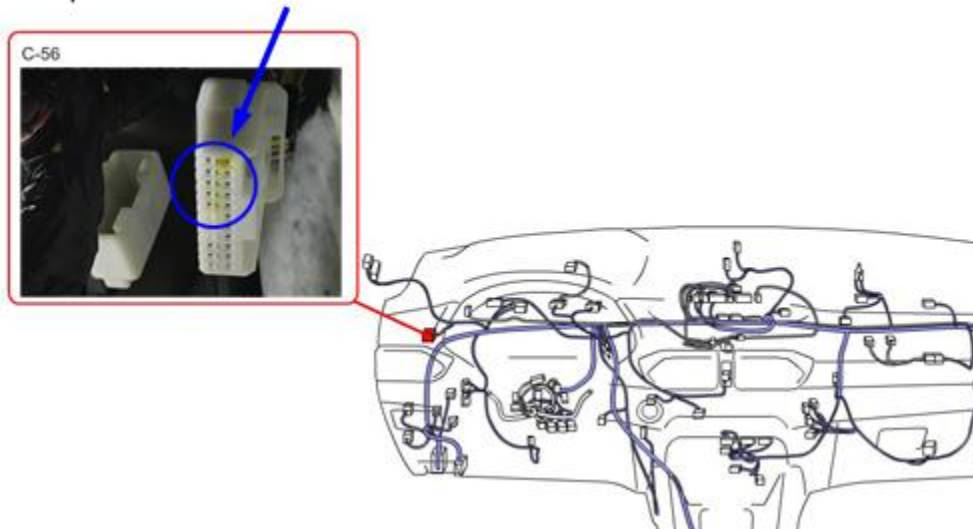
### Example of water contamination

During the aftermarket windshield tint installation, water is used by the installer. The tint installation may cause water contamination at connector C-56.
