**IB17-X-001A**

## INTRODUCTION TO FTR

- 2018MY Isuzu FTR

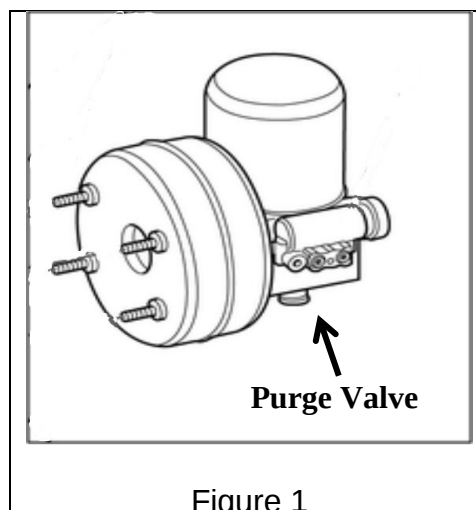
| Possible Customer Complaint | Normal Condition Description |
|---|---|
| Intermittent ticking or light knocking noise from engine area. | <u>Purge valve noise</u> - When the air tanks are at a full level, air from the compressor will exhaust (exit) from the bottom of the dryer. A ticking/light knocking sound may be heard from the exhausting air. This sound can be confused with an engine noise when standing outside of the vehicle on the driver's side at the back of the cab. This sound from air exiting the dryer is normal and does not require repair. <b>(See Figure 1 below for purge valve location)</b> |
