LTB00823NAS2

TECHNICAL BULLETIN

204-01: Front Suspension

'Creak' Noise From Stabilizer Bar Bushing-Front

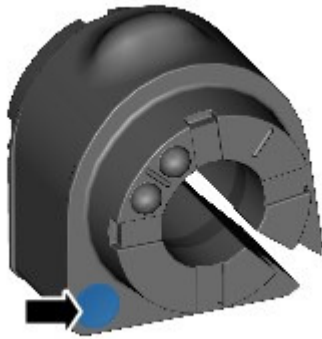
E182199

The new stabilizer bar bushing-front can be identified by a YELLOW painted dot in the area shown.

Lubricant must NOT be used when installing the new stabilizer bar bushing-front.

Install new stabilizer bar bushings-front (see TOPIx Workshop Manual section 204-01: Front Suspension - Front Stabilizer Bar Bushing).
