TO: Service Locations

FROM: Service Systems Development

SUBJECT: **GHG14 DD13™ Turbocharger Wastegate Service Kit**

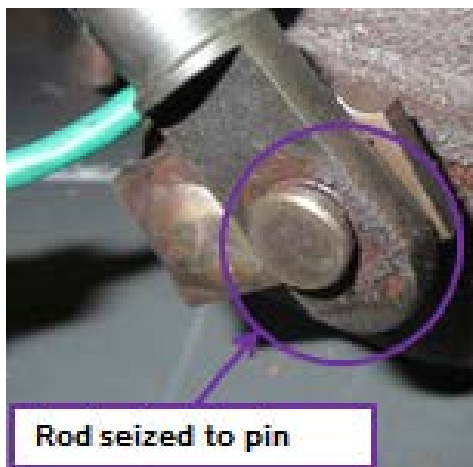
Some GHG14 DD13 engines (engine models 471927, 471933, 471934, and 471935) are experiencing one or more of the following fault codes. The codes are more likely to occur in hot and humid weather.

The cause of the code may be a stuck turbocharger wastegate mechanism due to several reasons, such as corrosion or a faulty wastegate diaphragm. See Figure 1.

**Figure 1 – Seized Wastegate Mechanism**

Follow the updated troubleshooting for MCM fault codes SPN 102/FMI 18 and FMI 16, and SPN 3464/FMI 16 in the *EPA07/10/GHG14 DDEC VI/10 Electronics and Troubleshooting Manual* (DDC-SVC-MAN-0084). Also check for previous fuel injector replacements to make sure the correct replacement part was used. For example, using EPA10 DD13 injectors in a GHG14 DD13 engine can cause these codes.

If the troubleshooting finds the turbocharger wastegate mechanism faulty, replace the mechanism with wastegate service kit P/N: A4710961769. This new serviceable wastegate has improved corrosion resistance.
