No.: 17 TS-15  
August 3, 2017

SUBJECT: **Misdiagnosed High Pressure Fuel Pump**

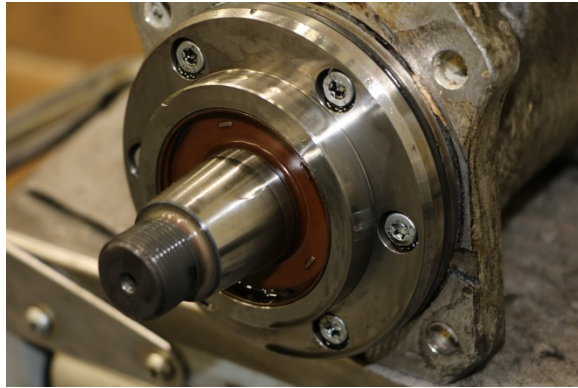
Example 1: Complaint: pump leaking oil

No damage to camshaft seal

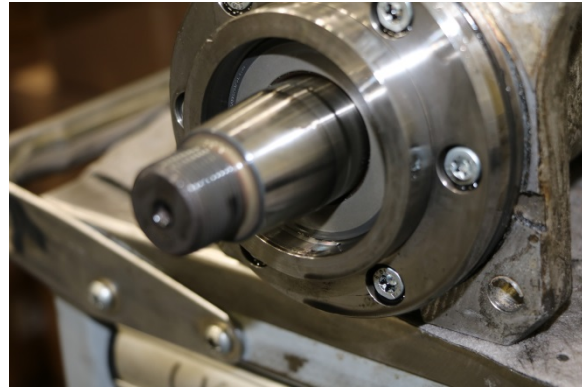
No oil behind camshaft seal

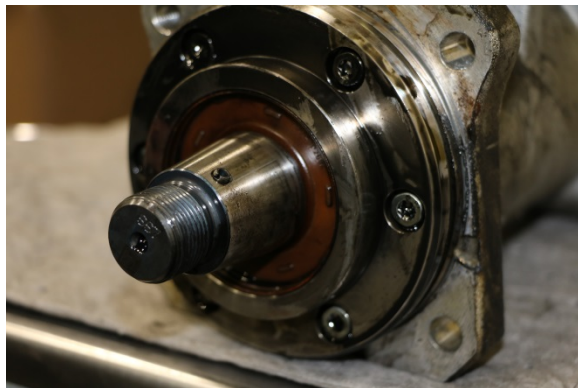
Example 2: Complaint: pump leaking oil

No damage to camshaft seal

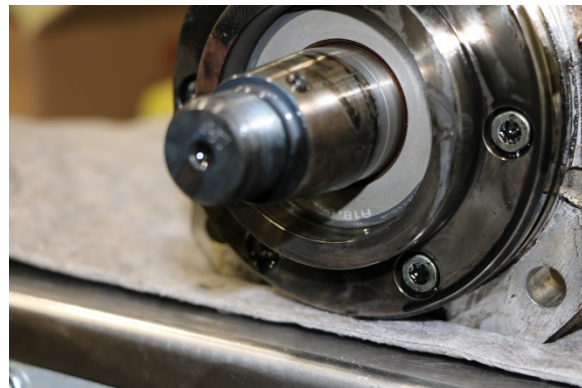
No oil behind camshaft seal

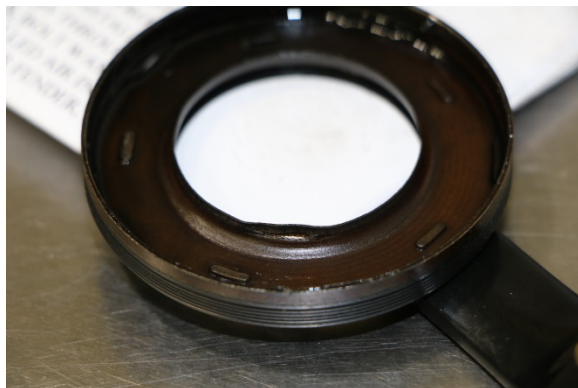
Example 3: Complaint: pump leaking oil

Failed New Style Camshaft Seal
