**August 2017
SF533A-O**

Subject: Instrument Cluster Update

Models Affected: Specific Freightliner 108SD, 114SD, and Business Class M2 models; and Freightliner Custom Chassis B2 school bus chassis (Thomas Built Buses Saf-T-Liner C2), and S2/S2C shuttle bus chassis manufactured January 12, 2015, through August 22, 2016, with Cummins ISB and ISL engines.

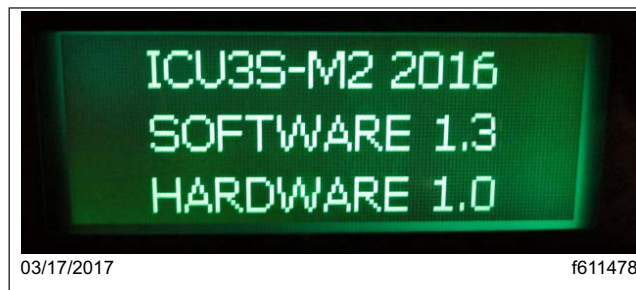
On certain Cummins equipped vehicles with alternators capable of producing in excess of 160 amps, the truck voltage may increase immediately after the Cummins grid heater cycles off, causing the ICU3S display to reset (looks like the reset that occurs during ignition key on). After reset, the ICU will resume normal function.

Fig. 1, ICU3S Screen Showing Software Version 1.3 (correct)

The ICU3S cluster will be replaced with an updated cluster with software version 1.3 or later. (The current software level of the ICU is displayed during warm-up, just after key on.)

If the software level of the ICU3S is 1.3, or higher, no further action is necessary. Continue with step 19.

If the software level is below 1.3, continue with the next step.
