LTB01112NAS1

# TECHNICAL BULLETIN

501-19: Bumpers

Hands-Free Tailgate - Unintentional Opening

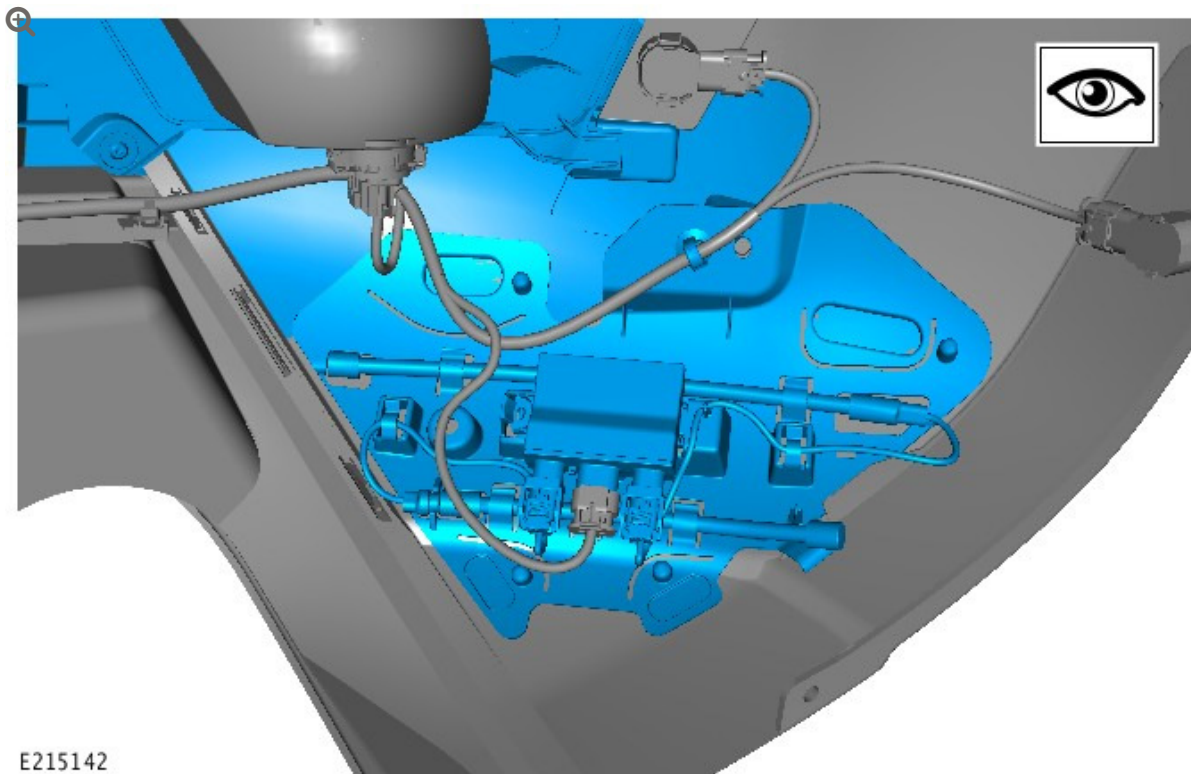
12

Inspect the areas shown in the illustration for water ingress.

- If there is no water present, **go to Step 13.**
- If there is water present, **repeat Steps 2-11.**
