LTB01111NAS1 TECHNICAL BULLETIN 14 NOV 2017

501-08: Exterior Trim and Ornamentation

Stainless Steel Exhaust Finishers Corroded/Discolored

MODEL:	MODEL YEAR:	VIN:	ASSEMBLY PLANT:
Range Rover Evoque (LV)	2012-2015	600018-999999	Halewood
Range Rover Evoque (LV)	2015 Onwards	000051 Onwards	Halewood

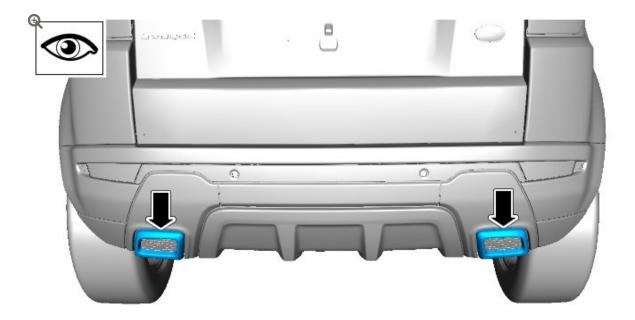
E215177

Visually inspect the left and right stainless steel exhaust finishers for evidence of corrosion/discoloration.

- If there is no evidence of corrosion/discoloration on the exhaust finishers,
 do not continue with this Technical Bulletin.
- If there is evidence of corrosion/discoloration on the exhaust finishers, go to Step 2.
