LTB01093NAS2

TECHNICAL BULLETIN

501-03: Body Closures

Tailgate - Cosmetic Microcracking

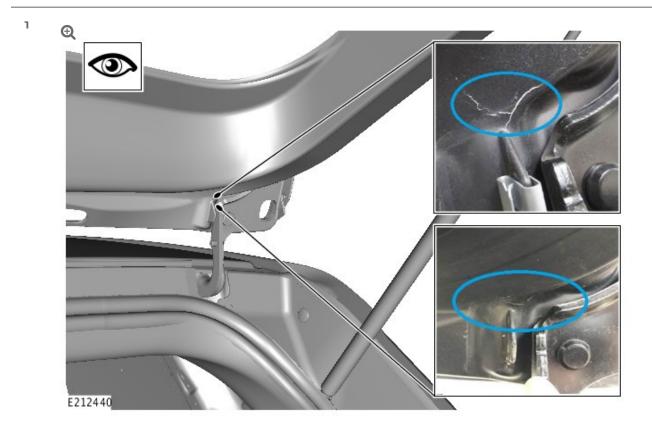
Cosmetic microcracking / surface cracks may be visible on the inside of the tailgate in the area of the hinge.

This may be caused by overextension of the tailgate.

Typical location of the microcracking (can occur on either or both sides of the tailgate).
