LTB00154NAS4

TECHNICAL BULLETIN

211-02: Power Steering

Squeak Noise From Steering Gear

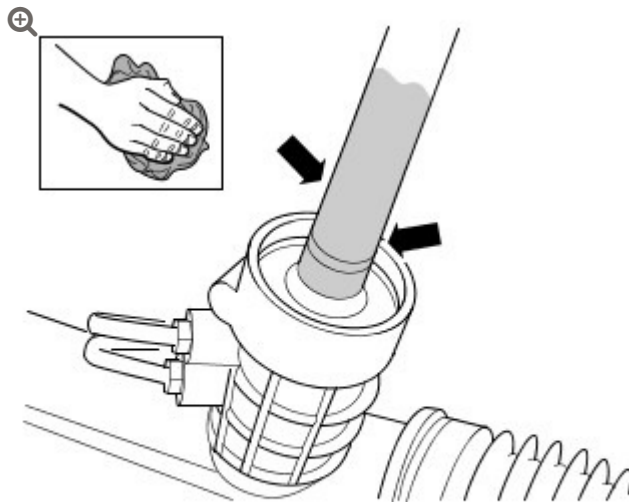
E104317

If any gouge/scratch or damage has occurred to the internal surfaces of the housing, a new steering gear must be installed.

Clean the pinion shaft and verify that no damage has occurred to the pinion diameter while removing the seal.
