LTB00663NAS6

# TECHNICAL BULLETIN

415-01: Information and Entertainment System

Steering Wheel Volume/Mode and/or Voice Activation Control Switch Not Functioning Correctly

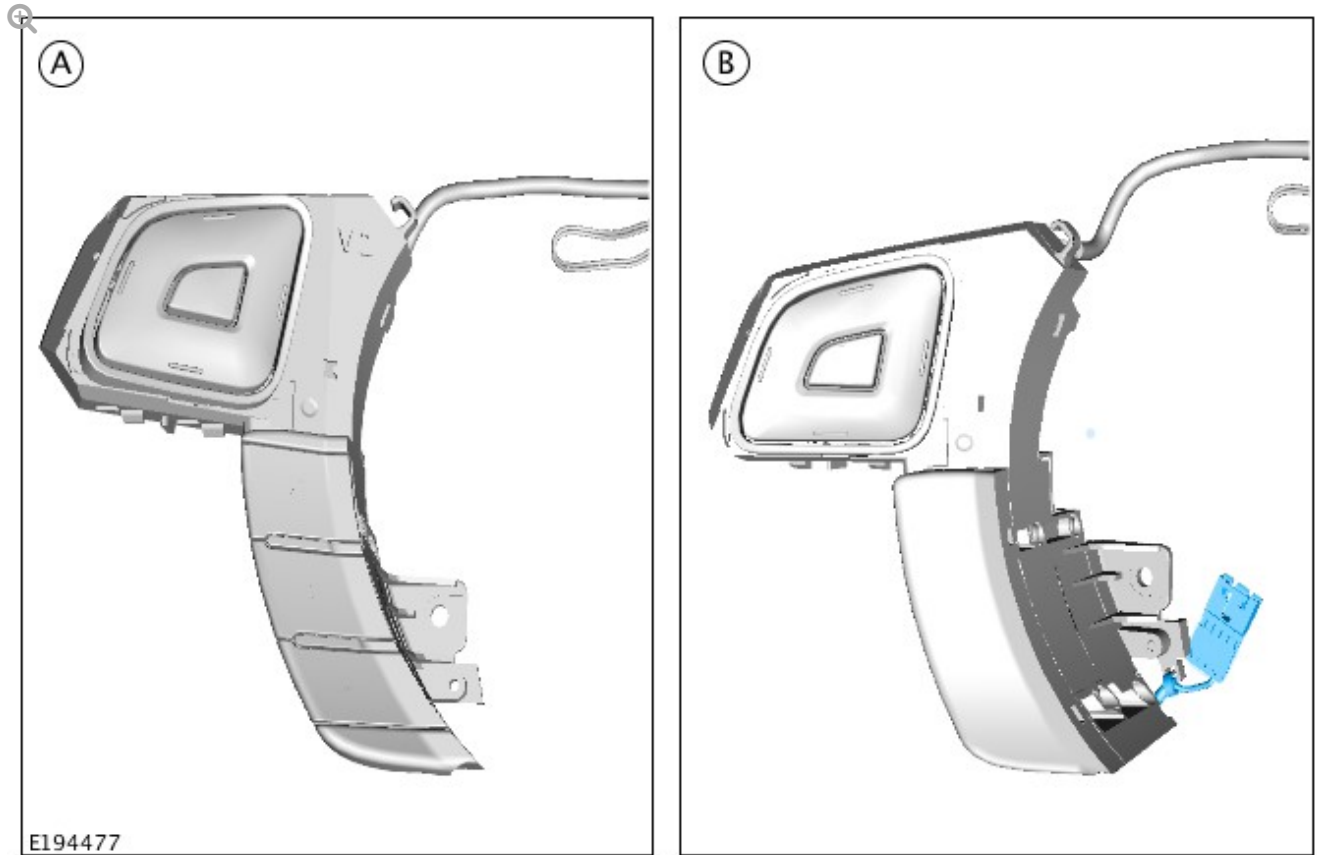
2

Non-heated steering wheel only.

- 1 Check if the additional ground wire (shown in illustration 'B') is installed as part of a previous repair.
  - If the additional ground wire is installed (B), do not continue with this Technical Bulletin.
    - Submit a Technical Assistance (TA) request.
  - If the additional ground wire is not installed (A), go to Step 4.

Remove the driver airbag (see TOPIx Workshop Manual section 501-20B: Supplemental Restraint System).

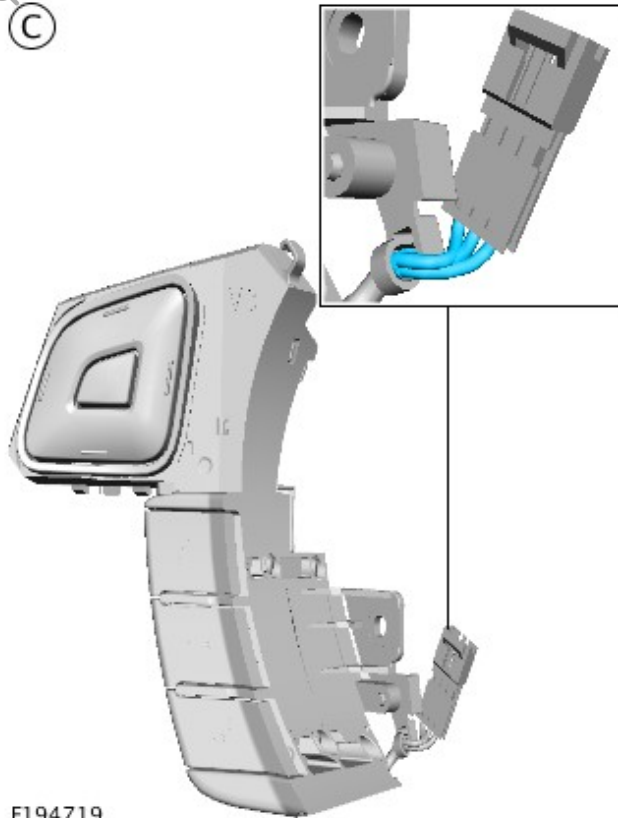
⊕  
C

Heated steering wheel only.

1 Check if the additional ground wire (shown in illustration 'D') is installed as part of a previous repair.

- If the additional ground wire is installed (D), do not continue with this Technical Bulletin.
  - Submit a Technical Assistance (TA) request.
- If the additional ground wire is not installed (C), go to Step 4.

Remove the driver airbag (see TOPIx Workshop Manual section 501-20B: Supplemental Restraint System).

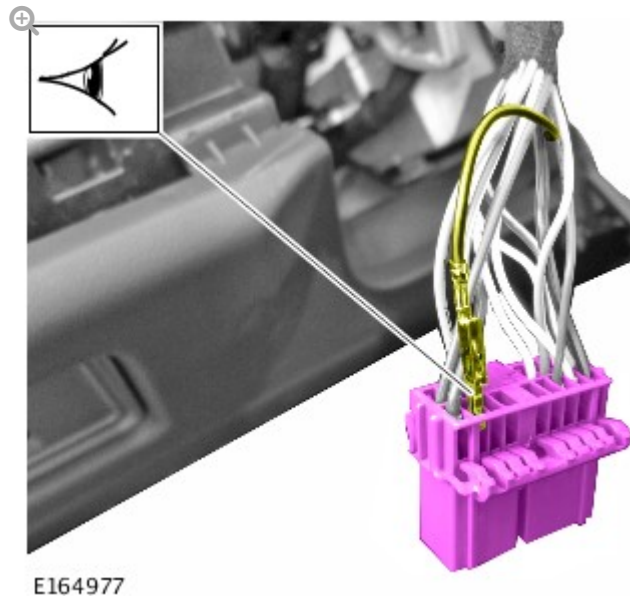
6

Observe the terminal size as they are different at each end on the new overlay harness.

Using pin out tool 418-595, back out the wire from cavity 15.

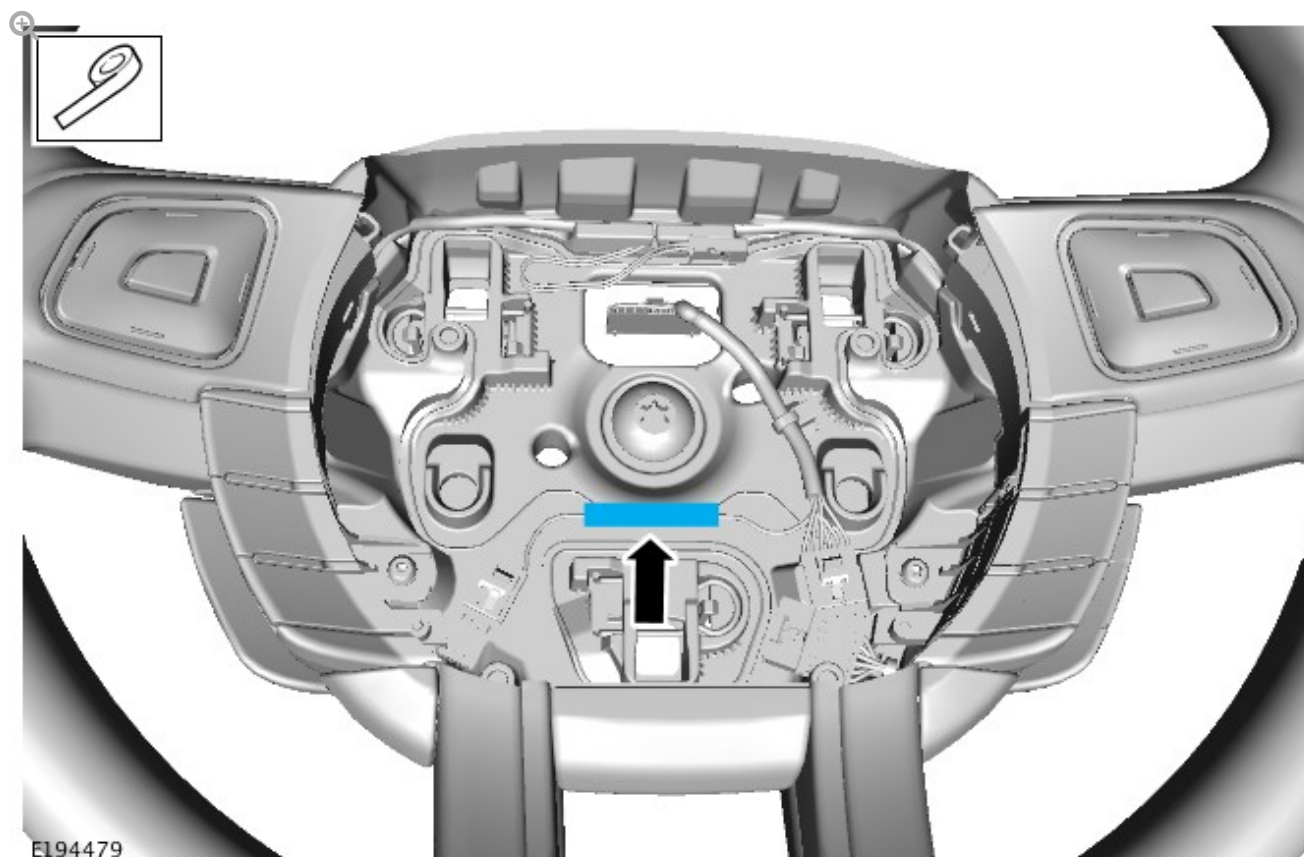
16

- Non-heated steering wheel only.
- Make sure that the harness is correctly routed and clipped into the steering wheel retainers.

Install the new In Car Entertainment (ICE; left-hand) switch and Overlay harness - Steering wheel (see TOPIx Workshop Manual section 211-04: Steering Column).

- 1 Clean the surface area behind the new ground wire location (see illustration) and allow to dry
- 2 Apply the adhesive tape (LR091563) in the location shown to the new ground wire, smoothing to ensure adhesion.
