LTB01090NAS1

# TECHNICAL BULLETIN

211-05: Steering Column Multifunction Switch

Indicator / Wiper Stalks Inoperative or Intermittent Function

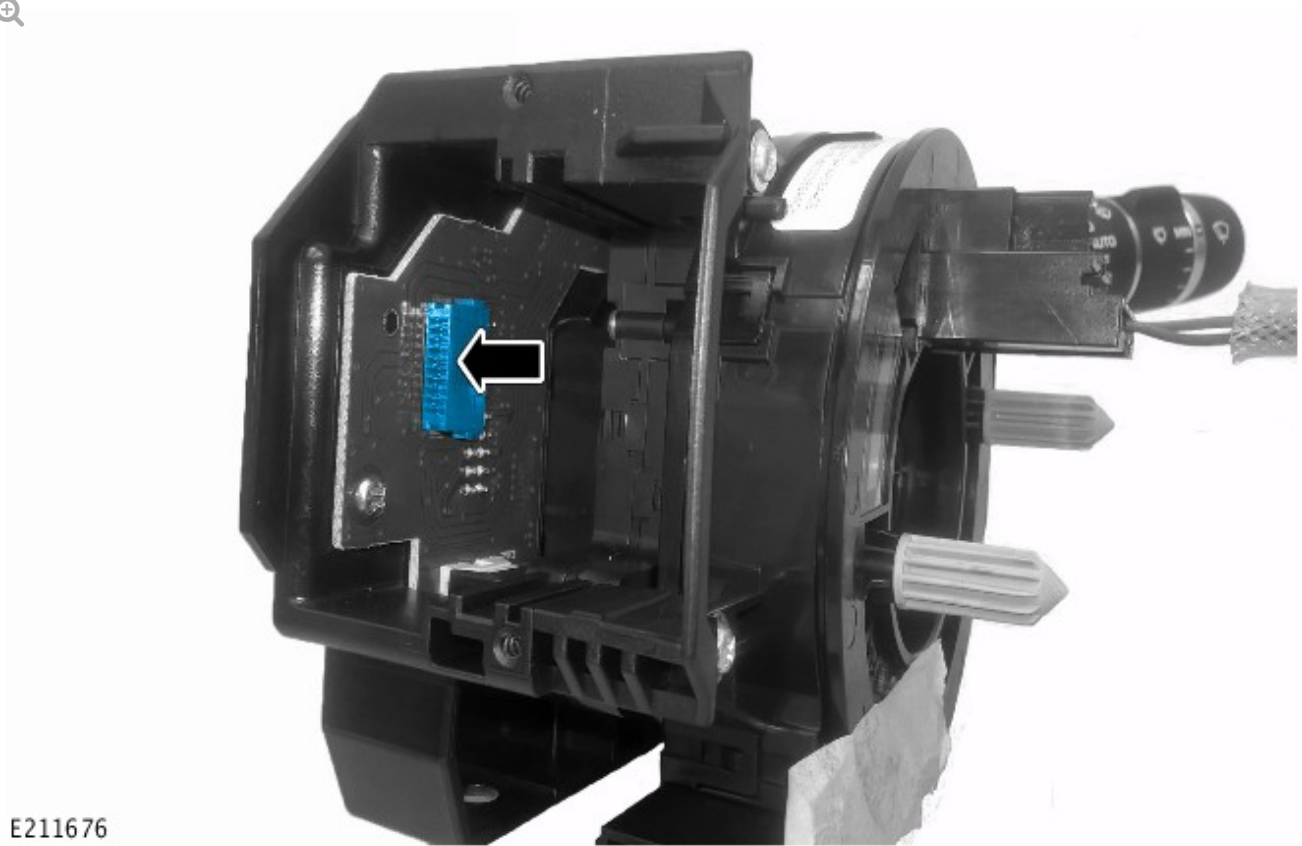
2

The lighting control switch and/or the wiper control switch may not operate or operates intermittently.

This may be caused by a poor electrical connection at the lighting control switch and/or the wiper control switch.

- Do not apply Nyogel to the lighting control switch connector.
- Make sure there is an even coating of Nyogel on the electrical contacts surface.
- Remove any excess Nyogel.

With the lighting control switch removed, apply the Nyogel to the electrical contacts surface.
