LTB01093NAS1

# TECHNICAL BULLETIN

501-03: Body Closures

Tailgate - Cosmetic Microcracking

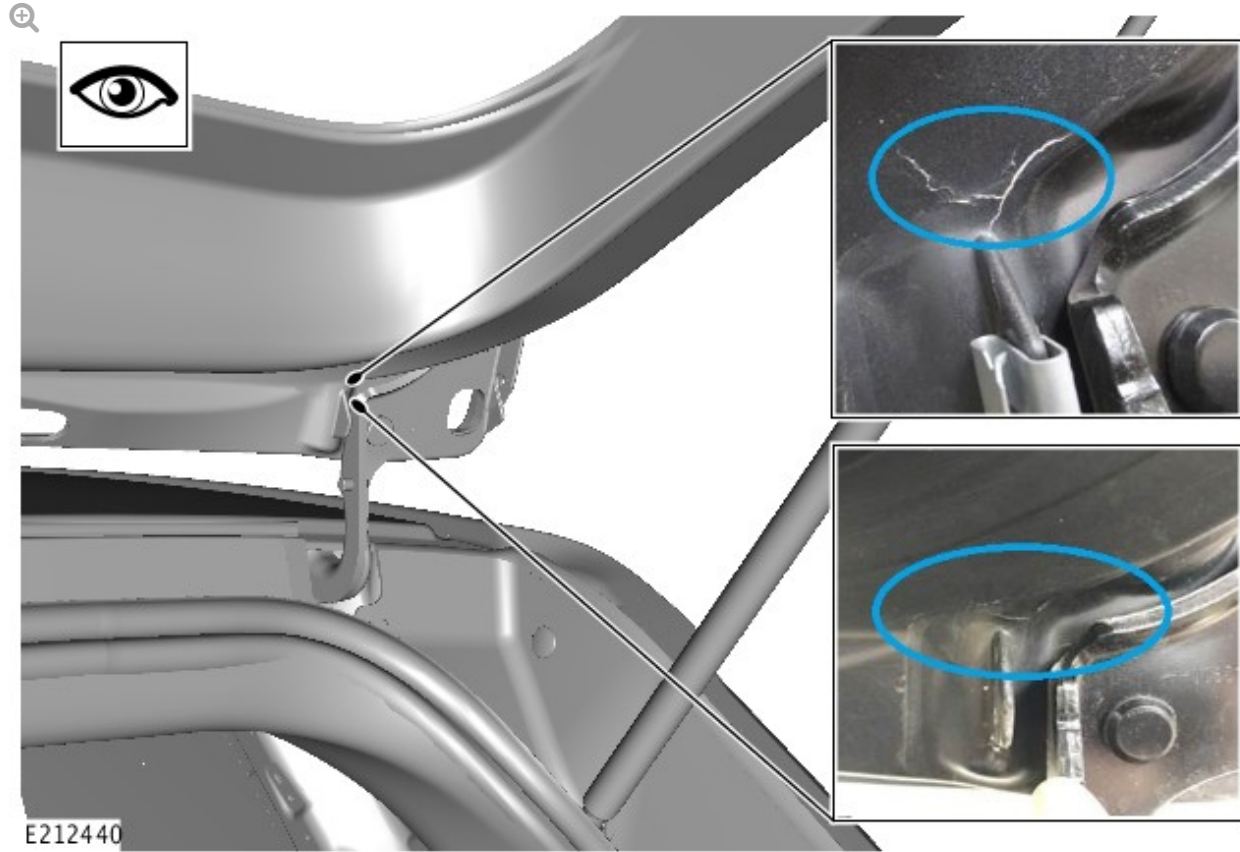
1

Cosmetic microcracking / surface cracks may be visible on the inside of the tailgate in the area of the hinge.

This may be caused by overextension of the tailgate.

Typical location of the microcracking (can occur on either or both sides of the tailgate).

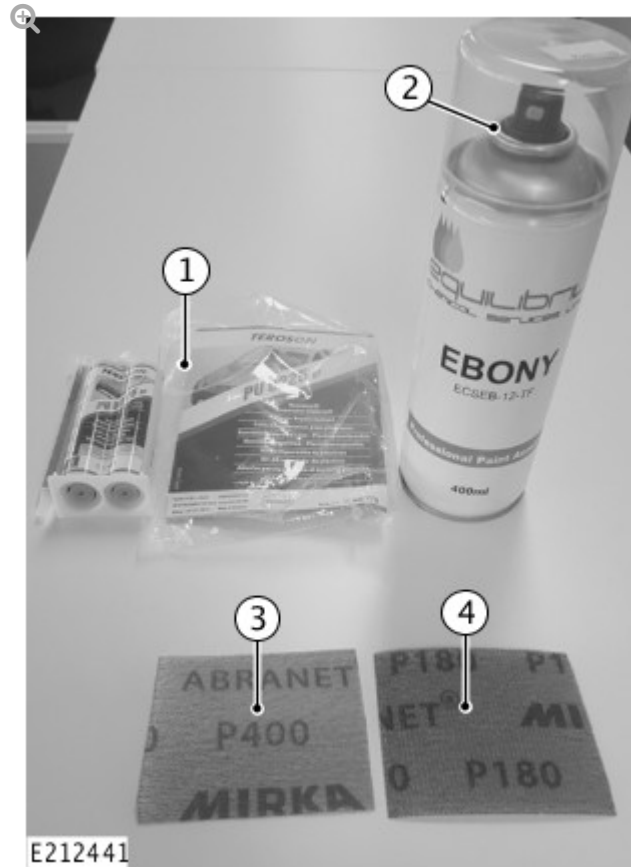
2

Contents of the repair kit.

- (1) TEROSON PU 9225 filler
- (2) EQUILIBRIUM spray paint
- (3) Sandpaper - P400
- (4) Sandpaper - P180
