LTB01110NAS1

TECHNICAL BULLETIN

Rear Bumper Exhaust System Heatshield Modification

MODEL:	MODEL YEAR:	VIN:	ASSEMBLY PLANT:
Discovery (LR)	2017 Onwards	000001 Onwards	Solihull

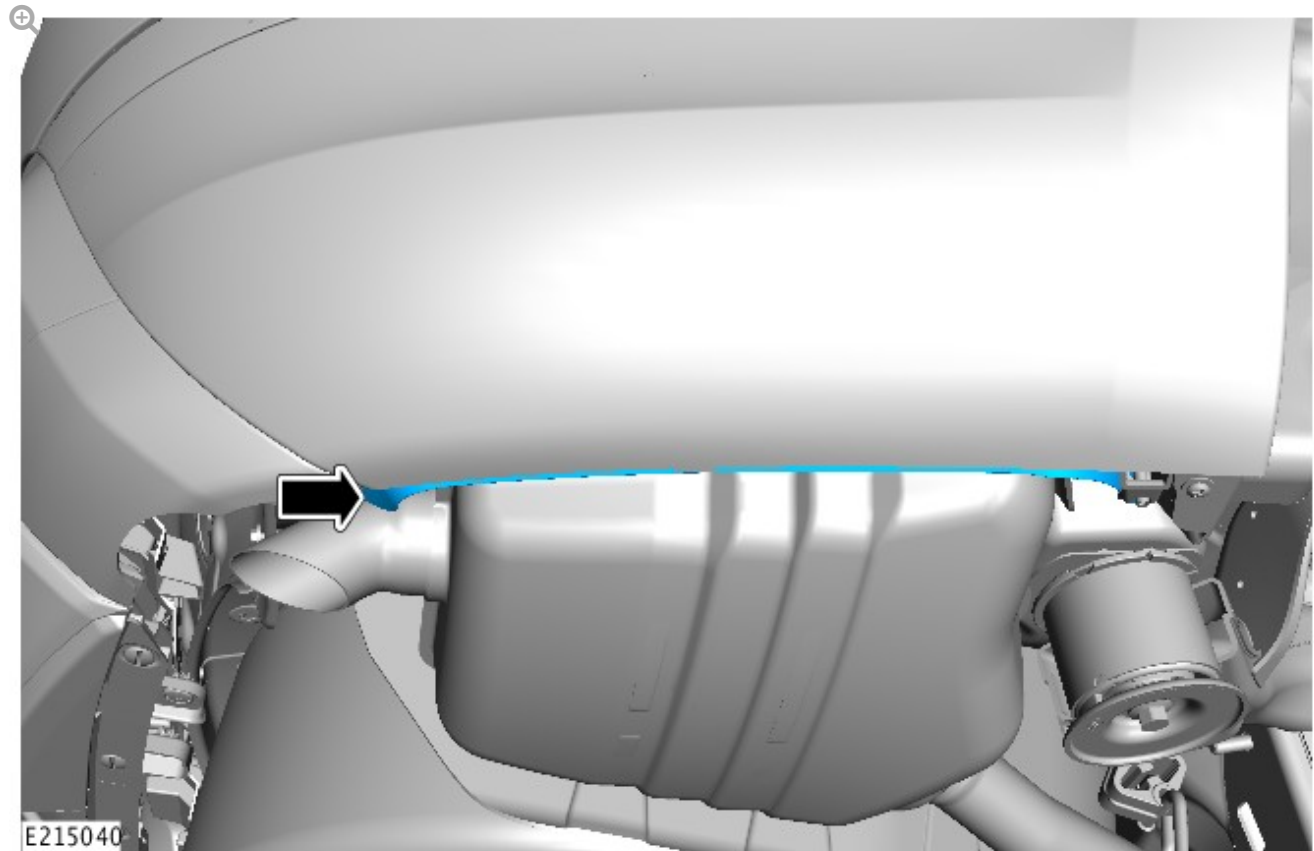
1

A sharp edge underneath the rear bumper may be evident.

This may be caused by the design of the rear bumper exhaust system heatshield.

Approximate position of the exhaust system right heatshield. Exact position may vary between vehicles.
