# Service Campaign

CC-17-00-29

MODEL: Karma Revero

TITLE: Baseline BL1030 Firmware Release

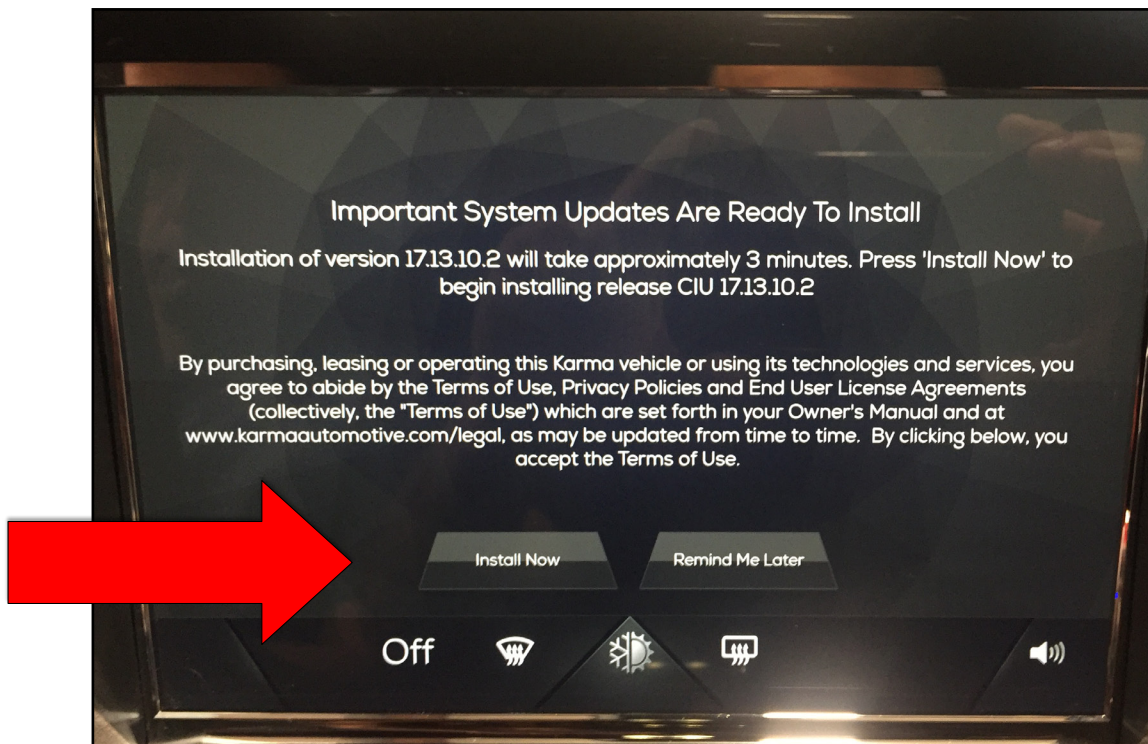
fig. 1

2. Keep the door latched (closed position) the update will not show up on TPI until power button is powered off with door still latched. This is when you can verify the TPI for update available messaging screen. If the download completed, the vehicle will prompt to accept the update (fig. 1) Accept this and allow the vehicle to update. Note that changing the door latch state will interrupt the accessory delay and shut down the TPI. If the TPI shuts down at power off, the update available screen will not display.

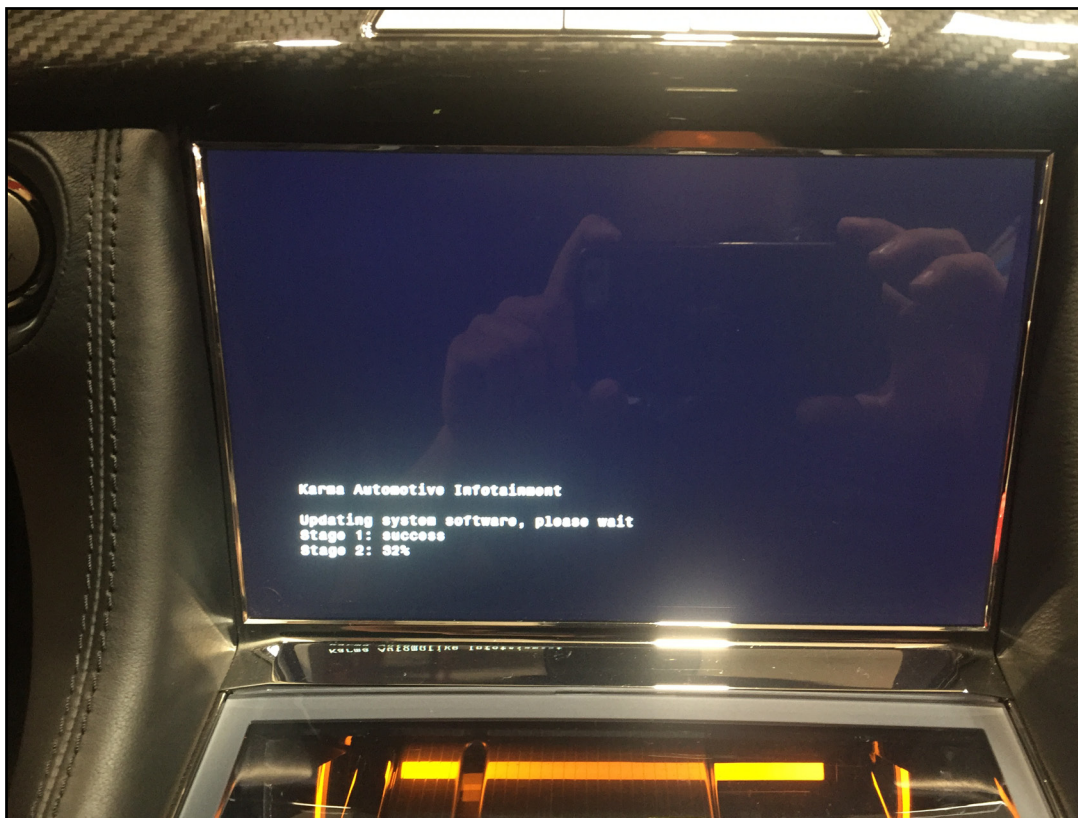
fig. 2

Below are the screens of the TPI read out as the CIU is updating (fig.2) When this is completed updating, the screen may go blank or black or cycle on and off, normal function will resume upon cycling the mode button.

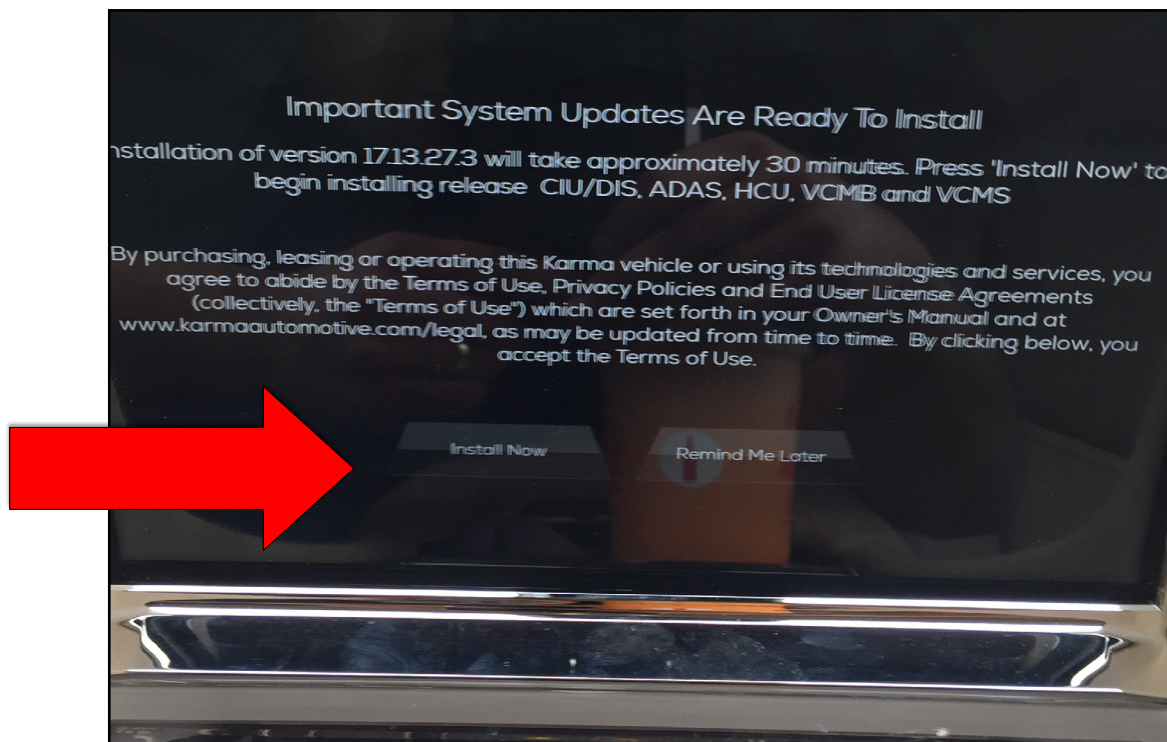
fig. 3

The second over-the-air install is for the rest of the package. Following the TSS representatives instructions you will get the screen (fig. 3) as shown below- hit install now.

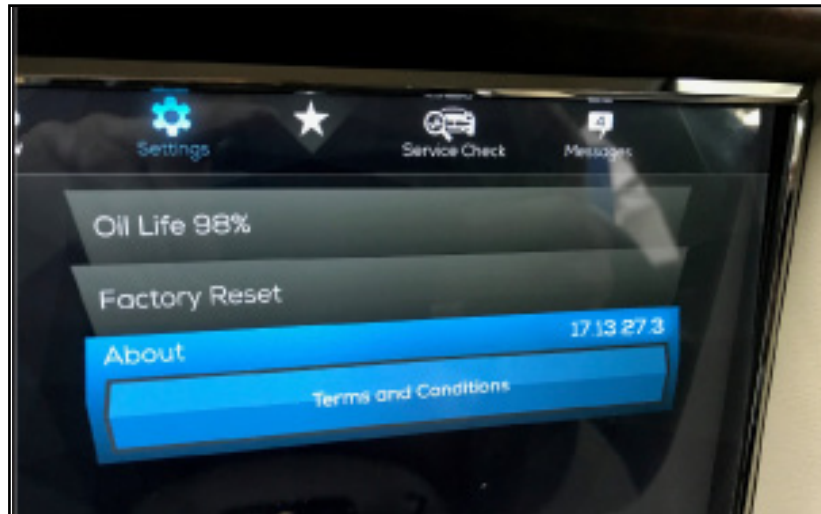
fig. 4

3. Verify the CIU software ID in the TPI after the vehicle has been placed in ready mode. go to Setting > About, the version should be displayed above the Terms and Conditions bar (fig. 4)

The CIU Software ID should be as displayed- 17.13.27.3.

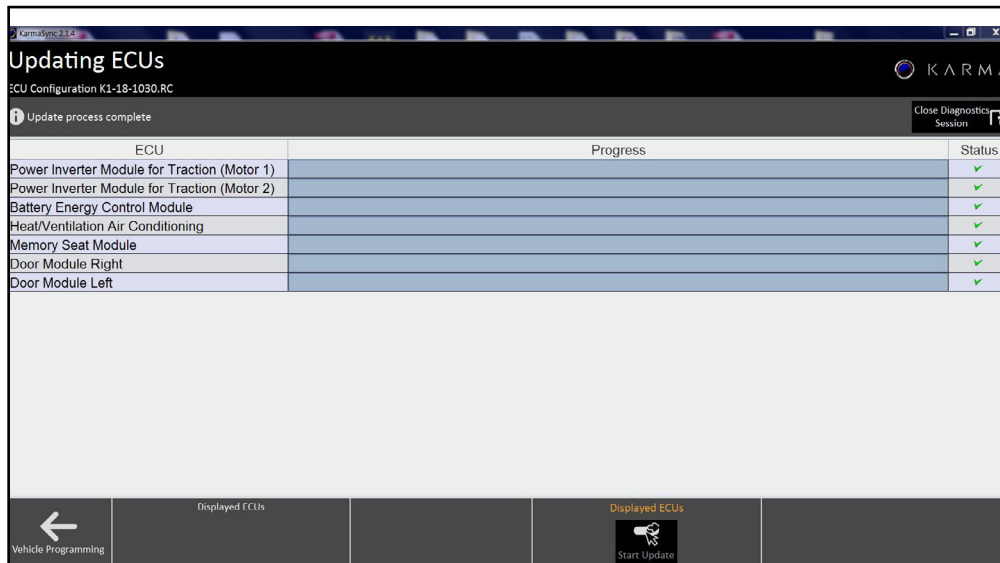
fig.18

When complete the green checks should appear.(fig 18)

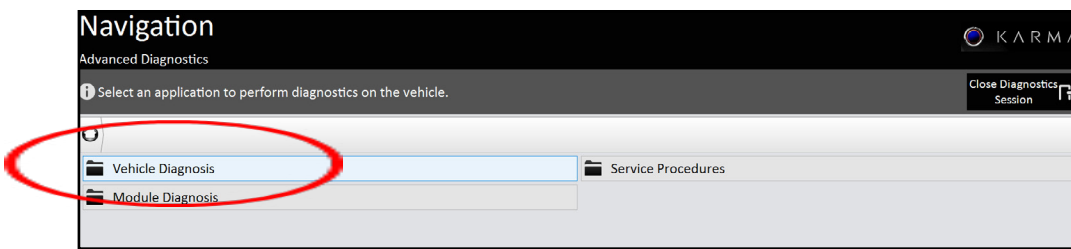
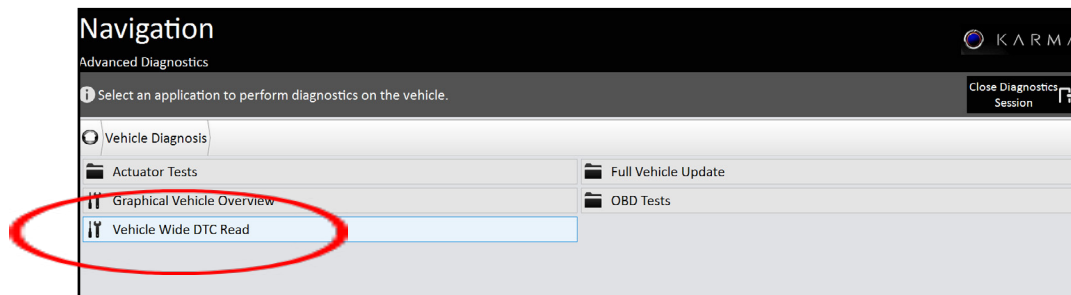
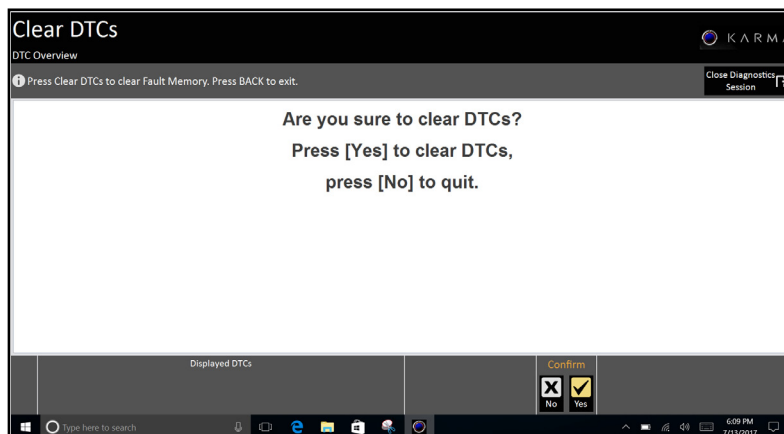
24. The update is complete with Karma Sync. Any codes need to be cleared in READY state. Ignore the pop-up of cycling state to ACCESSORY in Karma SYNC. Proceed to clear any DTC's present in the system. (fig.20a, 20b, 20c)

-If nothing is able to clear allow the vehicle to sleep for 10 minutes and make another attempt.

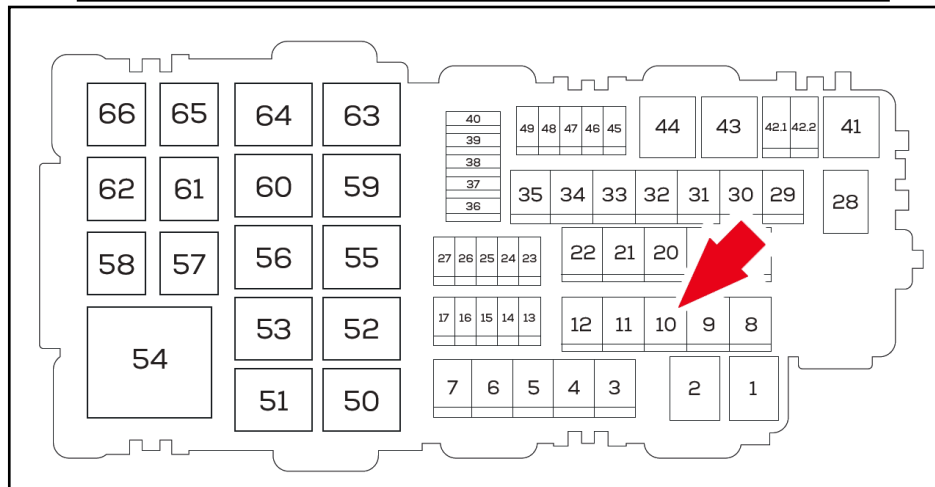
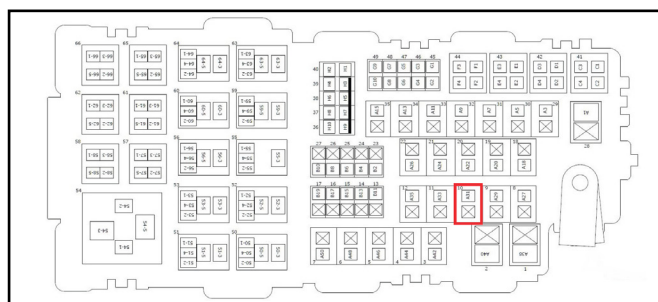
1. Open the fuse box under the hood (PDC) and remove fuse 10 (fig.21a, SPBC - solar panel boost controller)
2. Disconnect the main 12V ground disconnect (fig.21b)
3. Reconnect in reverse

**NOTE:** Do not install the solar fuse before connecting the main 12V ground as this will cause under voltage to the control units and may cause new concerns.
