SERVICE BULLETIN

APPLICABILITY: 2015-2017MY Legacy / Outback 2.5 CVT Models **NUMBER:** 16-104-17R
 2015-2016MY Crosstrek Hybrid (HEV) **DATE:** 02/23/17
SUBJECT: “Bump” Feeling from CVT at Idle in Drive **REVISED:** 05/30/17

This bulletin provides a diagnostic procedure along with Transmission Control Module (TCM) reprogramming files to address isolated customer concerns of a “bump” feeling from the CVT. The bump feeling has been reported to occur after the CVT is fully up to operating temperature, in Drive and with the engine at idle.

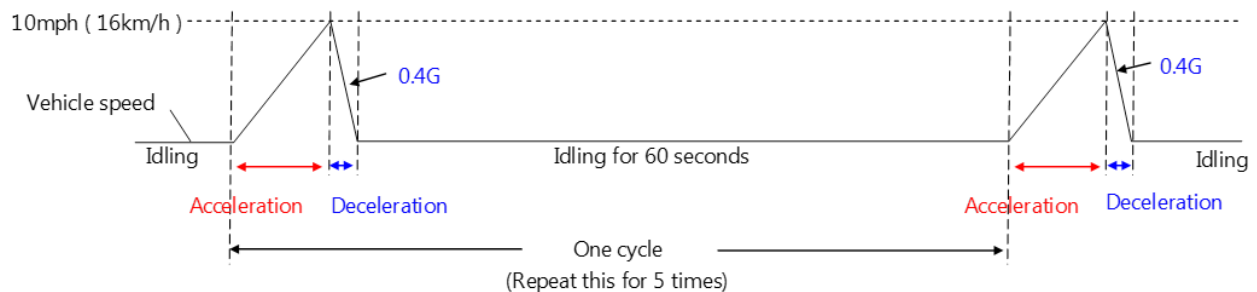
- Perform the test following the flow chart and graph supplied below.

CAUTION: Perform this drive testing only in a closed area (such as parking lot) away from other vehicle traffic and **never** on a public roadway due to the need to brake and hold position for 60 seconds during each test cycle. In addition, the use of a co-driver to either drive the vehicle or monitor the SM4 data during this testing is **strongly encouraged**.
