SI B16 02 13
Engine

Service Action: Delivery Stop N54 and N20 Engine - Replace Fuel Delivery Unit with In-Tank Pump

E89

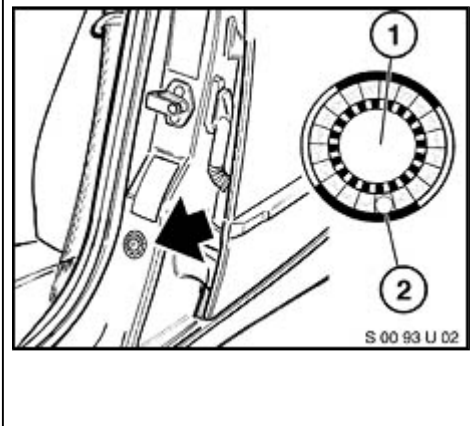
LABEL INSTRUCTIONS

<p>This Service Action has been assigned code number 663. After the vehicle has been checked and/or corrected, obtain a label (SD 92-420) and:</p> <ol style="list-style-type: none"> A. Emboss your BMW center warranty number in the middle of the label (1); B. Punch out code number 663 (2), printed on the label; and C. Affix the label to the B-pillar as shown.
---	---

If the vehicle already has a label from a previous Campaign, affix the new label next to the old one. Do not affix one label on top of another one, because a number from an underlying label could appear in the punched-out hole of the new label.
