122SD and Coronado  
Business Class M2  
> Cascadia  
108SD/114SD

**Freightliner  
Service Bulletin**

## General Information

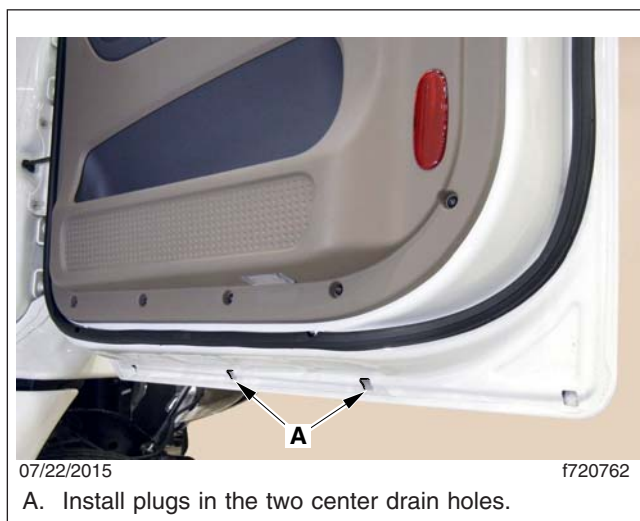
**Fig. 1, Cab Door Drain Holes**

On Cascadia vehicles built from November 25, 2013, the drain holes at the bottom of the cab doors were enlarged to improve drainage during the e-coat process in the manufacturing plant. The larger holes allow more cold air to flow through the doors, most noticeably in extreme cold conditions.

If an objectionable amount of cold air flows through the doors, seal the two center holes in each door with plugs. This will reduce the air flow significantly, while allowing for water drainage.

1. Park the vehicle on a level surface, shut down the engine, and set the parking brake. Chock the tires.
2. Open the door.
3. Install plugs (23-14161-000) in the two center holes in each door. See [Fig. 1](#) and [Fig. 2](#).
