**Subject:** Transmission Main Case – Oil Cooler Port Thread Change

**Document Number:** TAIB0864

**Date:** June 12, 2017

## Service Bulletin – Product

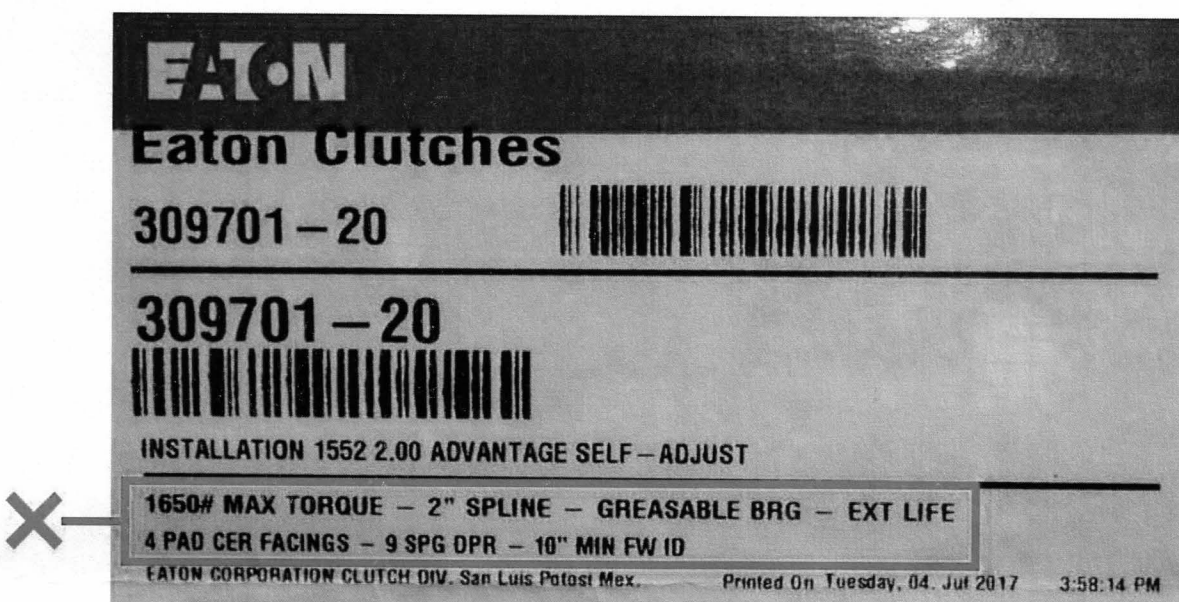
Some Advantage Series clutches manufactured between June 24 – July 21, 2017 may have box labels misprinted with incorrect product information including:

- Torque Ratings
- Number of Facings
- Number of Dampener Springs

This misprinting does not affect product performance. Box labels are printed with correct part numbers and clutches are properly manufactured, but labels may be printed with an inaccurate description of the clutch within. Use the [Eaton Clutch Selector \(CLSL1511\)](#) for correct product descriptions.

Eaton will send corrected replacement labels to customers requesting them.
