Technical Journal

Vibrations due to wheel / tire

REF NO: TJ 32161.4.0	ISSUING DEPARTMENT: Technical Service	CAR MARKET: United States and Canada	
PARTNER: 3 US 7510 Volvo Car USA		ISSUE DATE: 2017-11-27	STATUS DATE: 2017-12-04
FUNC GROUP: 7726	FUNC DESC: Summer tire, separate	Page 1 of 5

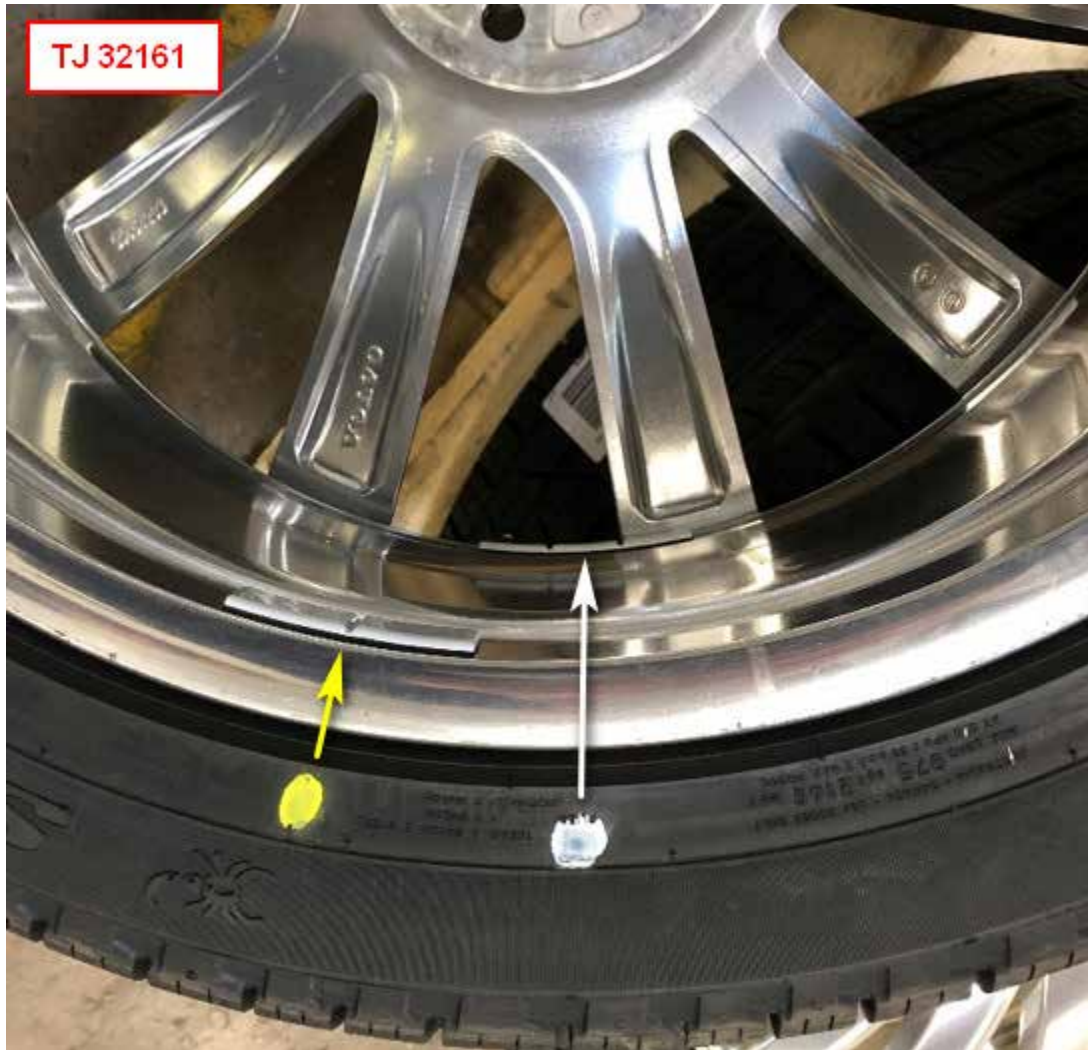
File Name	File Size
TJ 32161.jpg	0.0944 MB

1. Unbalanced wheel.
 - * Check that the rim is equipped with balancing weights. For newer wheels there should be visible white and a yellow dots printed on tire (inner side) indicating the location of the balancing weights, yellow for inner side, white for outer side (see photo). If balancing weights are missing but there are white and yellow dots on the tire, then it is likely that the weights has been lost and it is then needed to rebalance the tire.
 - * A new type of balance weights with better accuracy (1.25 grams instead or 5 grams) and better adhesiveness will be introduced 2017 Q4.
2. Tire pressure.
