TICKING NOISE WHILE CORNERING WITHOUT THE BRAKES APPLIED

G12 (7 Series)	F22 (2 Series coupe)	F23 (2 Series convertible)	
----------------	----------------------	----------------------------	--

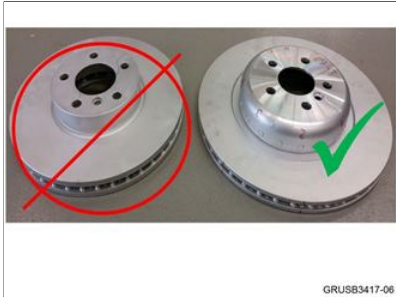
Microscopic slippage of contact surface interface between inner brake disc and wheel bearing flange on vehicles equipped with lightweight brake disc.

<ol style="list-style-type: none"> 1. Verify noise is being produced when the brakes are NOT being applied. 2. Check which type of brake disks are installed on the vehicle. <p>Are the lightweight disks (as shown on the right) installed on the vehicle? YES- Go to Step 3. NO – continue diagnosis with ISTA.</p> <ol style="list-style-type: none"> 3. Remove brake discs according to repair instruction 3411220 “Removing both front discs and installing and replacing”. 4. Clean the wheel bearing flange with brake cleaner 5. Install “friction ring” on wheel bearing flange as shown.
	<ol style="list-style-type: none"> 6. G12 Check vehicle history. <p>Is the vehicle more than 24 months old (from production date)? YES- Obtain new bolts for wheel installation. Discard removed bolts. Go to next step. NO – go to next step.</p>

Remove front brake discs and install friction ring between the brake disc and wheel flange.

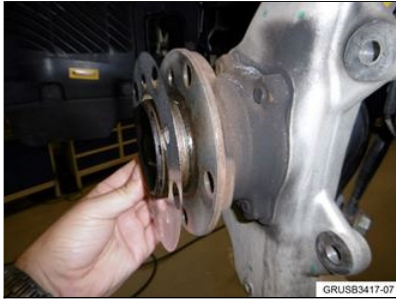
F22, F23: The wheel bolts must be replaced in vehicles produced up to 07/2017.

7. Reinstall all removed parts according to repair instruction 3411220 "Removing both front discs and installing and replacing".
8. Repeat procedure for opposite front wheel.
