NOISE FROM HEAD AIR BAG

F60			
-----	--	--	--

Produced from 2/24/17 to 4/5/17.

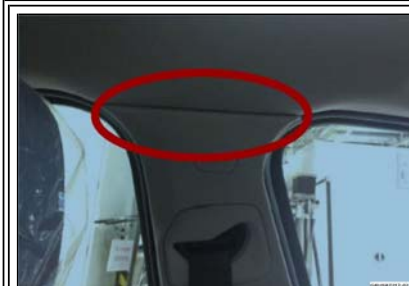
During low outdoor temperatures, with the doors and windows closed, a metallic whirring noise is detected in the area of the head air bag (HPS).

Insufficient clearance between vehicle body and head air bag assembly.

1. Follow repair instructions 72 12 061 – “Remove and install/replace left and right head air bag” but do not remove the head air bag. Headliner can be left on top of seats leaving enough room to work above headliner.
 2. Expose the head air bag gas generator
- (Please Do Not remove the air bag and/or windshield).**
3. Cut a 10 cm length filler piece of sponge rubber
