NUMBER: 14-003-17

Fuel Weeping From Number Three Cylinder Injector Return Hose

2017 (DS) RAM 1500 Pickup

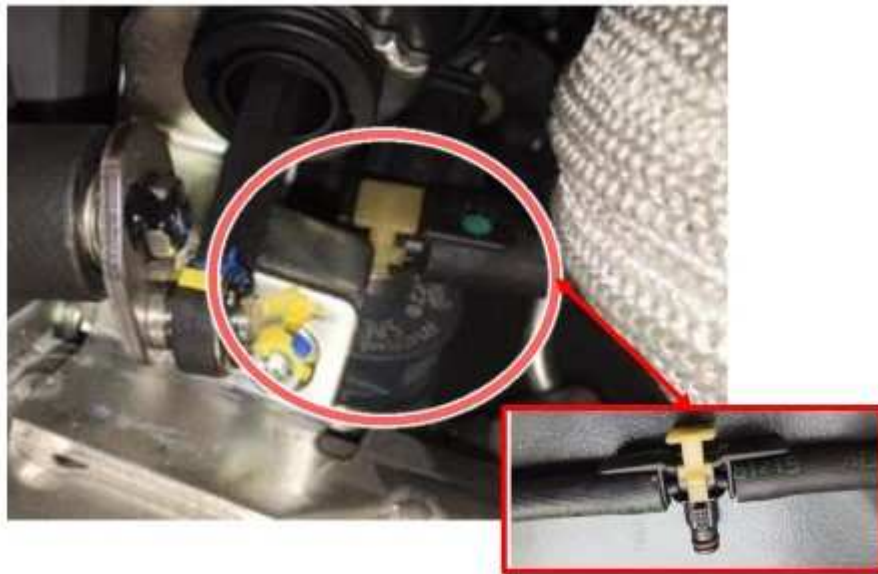
Fig. 1
Injector Return Hose

Some customers may experience a fuel smell and/or weepage. Upon further investigation, a technician may notice the issue emanating from under the hood at the number three cylinder injector return hose connector.

1. Remove the engine cover. Refer to the detailed service procedures available in DealerCONNECT> TechCONNECT under: Service Info>09 - Engine, 3.0L Turbo Diesel/Cover, Engine/Removal.
2. Remove the air intake tube. Refer to the detailed service procedures available in DealerCONNECT> TechCONNECT under: Service Info>09 - Engine, 3.0L Turbo Diesel/Air Intake System/Body, Air Cleaner/Removal>Intake Air Tube.
3. Remove the injector silencer pad from the engine.
4. Inspect the white latch at the #3 cylinder fuel injector return hose for not being fully seated ([Fig. 1](#)) . Proceed to [Step 1](#) of the repair procedure.

1. Push down and fully seat the white latch for the #3 cylinder fuel injector return line down onto the fuel injector and pulling back to ensure the white latch is seated properly (Fig. 2) .

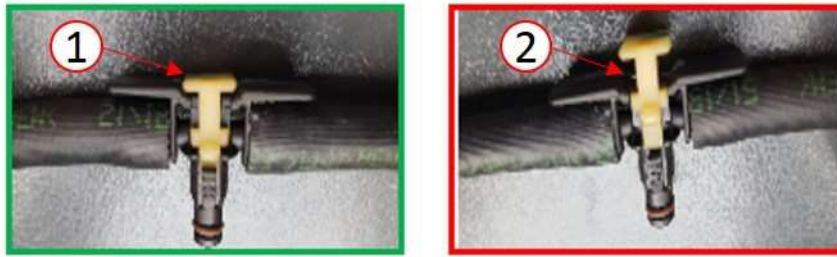
Fig. 2
Properly Seated Latch

- 1 - Properly Seated Latch (Down Position)
- 2 - Latch Not Properly Seated (Up Position)
