NUMBER: 08-088-17 REV. A

Tighten Negative Battery Cable

This bulletin involves tightening the negative battery cable to proper torque at the gearbox.

2017 (M1) Jeep Compass (Brazil)

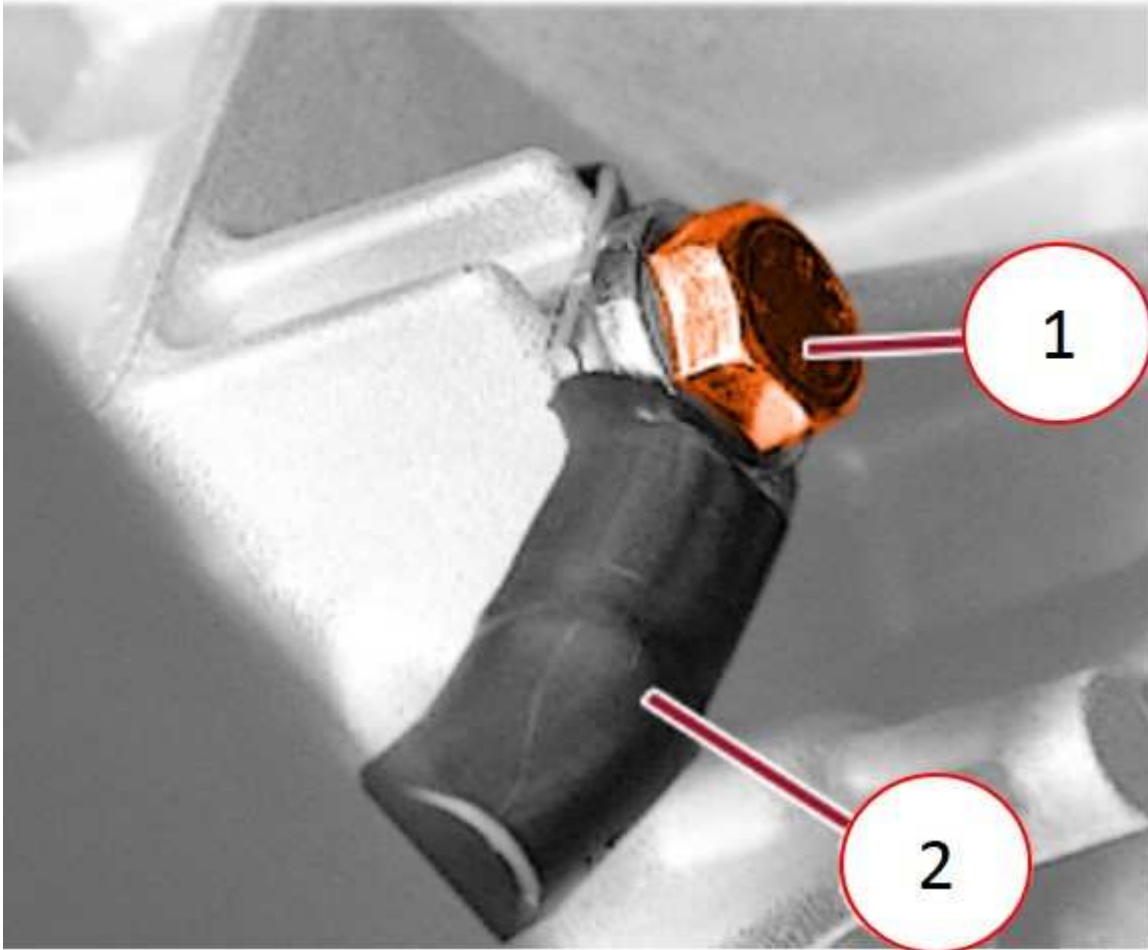
Fig. 1
Negative Battery Cable

Some customers may experience difficulty in starting or a no crank situation.

1. Raise and support the vehicle. Refer to the detailed service procedures available in DealerCONNECT> TechCONNECT under: Service Info>04 - Vehicle Quick Reference/Hoisting/Standard Procedure.
2. Remove the left front wheel house splash shield. Refer to the detailed service procedures available in DealerCONNECT> TechCONNECT under: Service Info>23 - Body/Exterior/Shield, Splash, Front Wheelhouse/Removal and Installation.
3. Tighten the bolt for the negative battery cable at the gearbox (Fig. 1) . Tighten to 22 N·m (16 ft. lbs or 194 in. lbs).
