NUMBER: 23-047-17

Seat Pops or Clicks After Seatback Is Adjusted

2017 (RU) Chrysler Pacifica

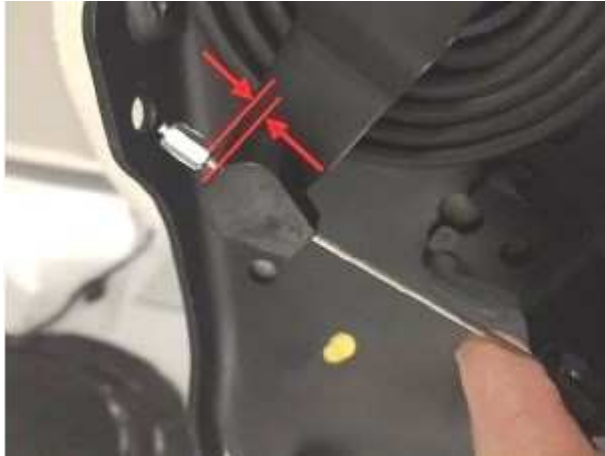
Fig. 1
Cable Slack

3. Check the slack on the recliner cable from the end of the fitting to the crimp. It should have approximately 0.5 mm to 2.0 mm (0.01 in. to 0.07 in.) of slack. Does the recliner cable fall in the slack range (Fig. 1) ?
- YES>>> This bulletin does not apply. Normal diagnosis should be performed.
 - NO>>> Cable is tight. Continue with the Repair Procedure. Proceed to [Step 4](#).
