NUMBER: 08-107-17

DATE: November 3, 2017

Loose High Voltage Cable at the Power Inverter Module (PIM) Terminal

2017 (RU) Chrysler Pacifica (PHEV)

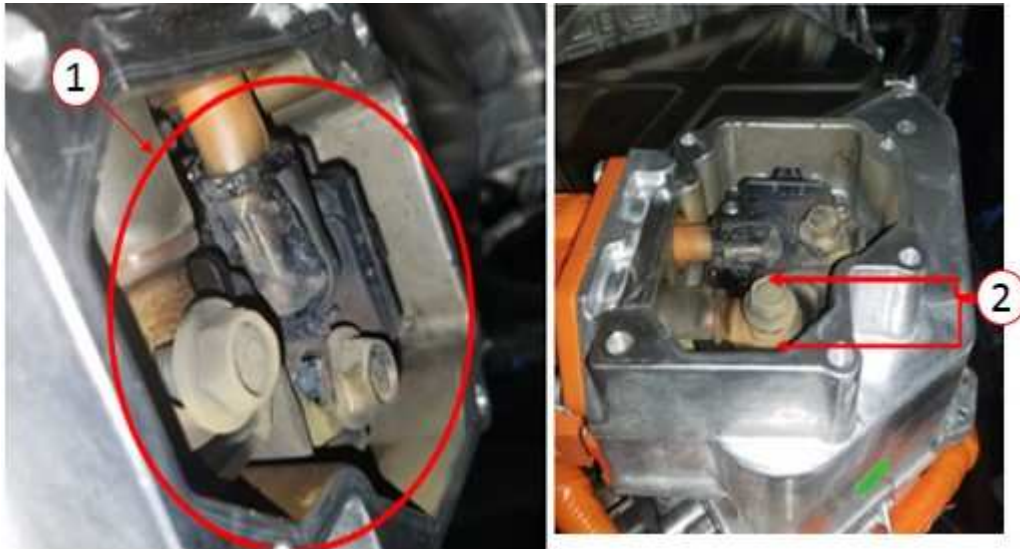
Fig. 1
HVIL Connector

2. Remove the HVIL cover panel and check the terminal bolts for signs of arcing from the high voltage current, **take a digital image, see step Step 3** after digital image is taken, ensure they are torqued to 25 N·m. (212 in.lbs) (Fig. 1) .
3. Before the HVIL connection is disturbed, digital image in a manner that the high voltage bolts are captured (I.E. from a 45° angle so that if the bolts are loose, any gaps will be seen), while the PIM is in the vehicle (Fig. 1) .
4. Take picture for digital imaging after removal of the PIM HVIL cover of the terminal bolt.
 - a. Record any active/stored DTCs.
 - b. Record the torque value of both PIM terminal bolts. If under 25 N·m. (212 in.lbs), tighten to specifications.
 - c. Record vehicle mileage.

- 1 - Terminal Arcing and Loose Bolt
 - 2 - 45° Angle for Digital Imaging
-

- YES>>> Proceed to [Step 1](#) of the repair procedure.
- NO>>> Verify correct torque on the bolt. Tighten to 25 N·m. (212 in.lbs). This bulletin has been completed. Use inspect LOP (08-90-16-90) to close the active RRT.

1. Replace the PIM. Refer to the detailed service procedures available in DealerCONNECT> TechCONNECT under: Service Info>08 - Electrical/8E - Electronic Control Modules/Module, Power Inverter, High Voltage/Removal and Installation.
2. Replace the high voltage cable to the PIM. Refer to the detailed service procedures available in DealerCONNECT> TechCONNECT under: Service Info>08 - Electrical/8F - Engine Systems/ Battery System/Cables, Battery High Voltage/Removal and Installation.
3. Install the new bolts. Tighten to 25 N·m. (212 in.lbs).
