**NUMBER:** 08-007-17 REV. H  
**GROUP:** 08 - Electrical  
**DATE:** November 29, 2017

UAS, UCQ, UDQ, UJQ and UAQ Radio Enhancements

This bulletin involves inspecting and if required, updating the radio software.

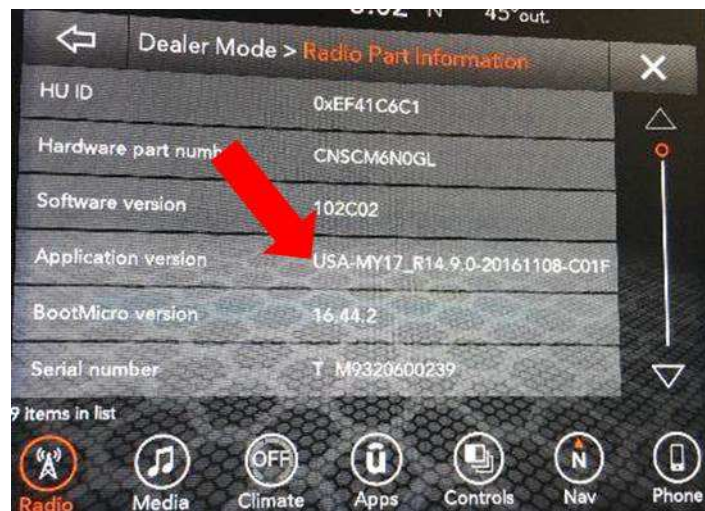
**Fig. 1****Radio Software Level Screen****REPAIR PROCEDURE:**

1. Verify the radio software version. Radio must be in Dealer Mode to verify by following these steps:
  - a. Push and hold the Front Defrost, Driver Temperature Up and Temperature Down buttons simultaneously until the Dealer Mode screen appears (approximately seven seconds). Release buttons.
  - b. Select "Radio Part Information". The software version will be listed next to "Application Version".
2. Is the radio currently at software level 16.11 or higher (Fig. 1) ?
  - YES >>> The radio software is already up to date. This bulletin has been completed, use inspect LOP (18-60-02-LT) to close the active RRT.
  - NO >>> The radio software needs to be updated. Back out of Dealer Mode and proceed to [Step 1](#) of the Repair Procedure.
