NUMBER: 08-023-17

Flash: Brake System Module (BSM) Improvements

This bulletin involves updating the BSM with the latest available software.

Jeep Compass (Brazil)

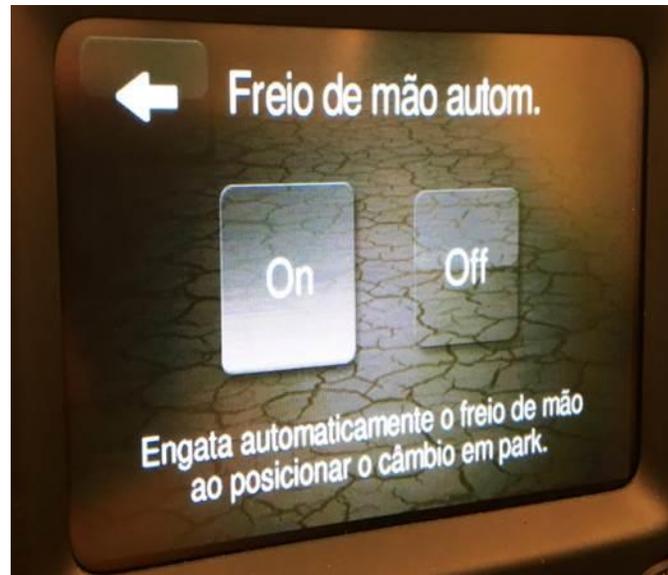
Fig. 1 Auto Park Brake

The customer may experience the Auto Apply Park Brake indicator has been disabled under the radio settings (Fig. 1) when the Electronic Park Brake (EPB) is engaged and the ignition is cycled.

2. Reprogram the BSM/ABS module with the latest software. Detailed instructions for flashing control modules using the wiTECH Diagnostic Application are available by selecting the application's "HELP" tab.
3. Using the wiTECH, perform the Proxi Alignment Procedure located in the Body Control Module (BCM) icon, under the "Miscellaneous Functions" tab.

4. Using the wiTECH Diagnostic Application, perform the following routines:
 - a. Brake Pedal Calibration - located in the ABS module icon, under the "Miscellaneous Functions" tab.
 - b. Longitudinal G-Sensor Calibration - located in the ABS icon, under the "Miscellaneous Functions" tab.
 - c. EPB Service Procedure - "Exit Plant Mode" and "Assembly Check" located in the ABS module icon, under the "Miscellaneous Functions" tab.
5. Clear any DTCs that may have been set in other modules due to reprogramming. The wiTECH application will automatically present all DTCs after the flash and allow them to be cleared.
