NUMBER: 21-012-17

GROUP: Transmission and Transfer Case

Transfer Case Input Seal Leak

2016 (JK) Jeep Wrangler

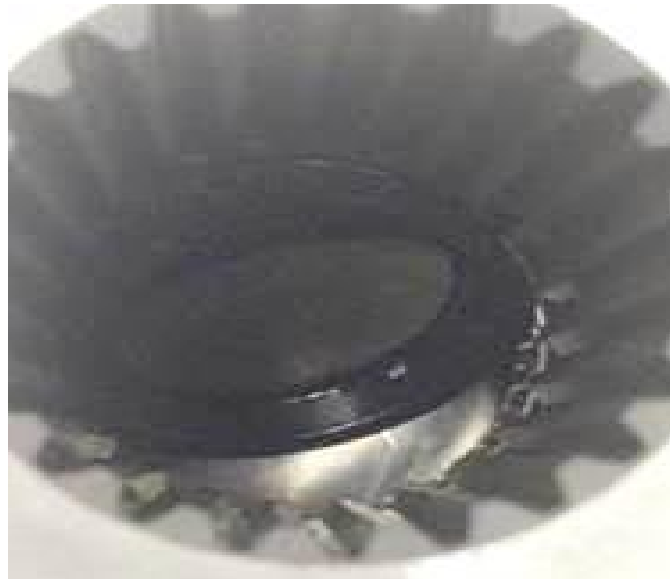
CAUTION: If the input gear cap plug is dislodged, out of position or loose, do not attempt to fix or reinstall the cap plug (**Fig. 1**). Attempting to fix cap plug will not correct the issue and will result in the issue reoccurring.

Fig. 1 Dislodged Cap Plug

1. Remove the transfer case. Refer to the detailed service procedures available in DealerCONNECT> TechCONNECT under: Service Info>21 - Transmission and Transfer Case/Transfer Case, NV241 GenII/Removal.
2. Replace the transfer case input gear and seal. Refer to the detailed service procedures available in DealerCONNECT> TechCONNECT under: Service Info>21 - Transmission and Transfer Case/Transfer Case, NV241 GenII/Disassembly/Assembly.
3. Install the transfer case. Refer to the detailed service procedures available in DealerCONNECT> TechCONNECT under: Service Info>21 - Transmission and Transfer Case/Transfer Case, NV241 GenII/Installation.
