NUMBER: 23-017-17

Gap Between Door Trim Panel And Inner Belt Molding

2017 (DS) RAM 1500 Pick Up

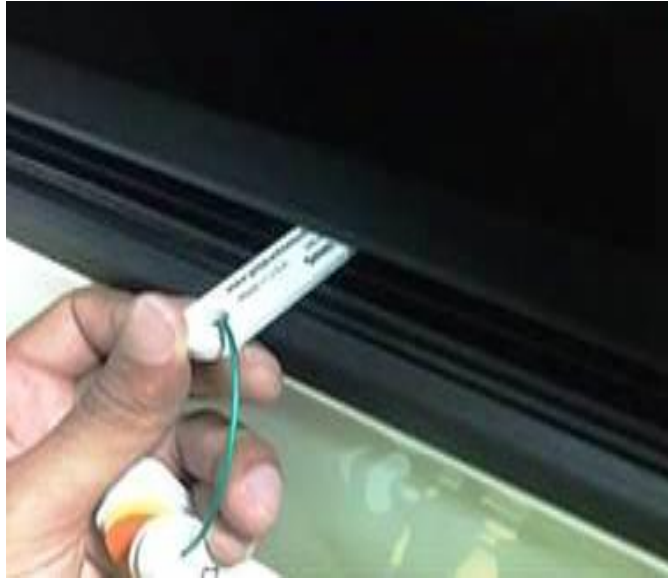
Fig. 1 Measuring Gap

2. Using a feeler gauge, measure at the center of the window opening between the door panel and inner belt molding (ensure it is perpendicular to the door) ([Fig. 1](#)).

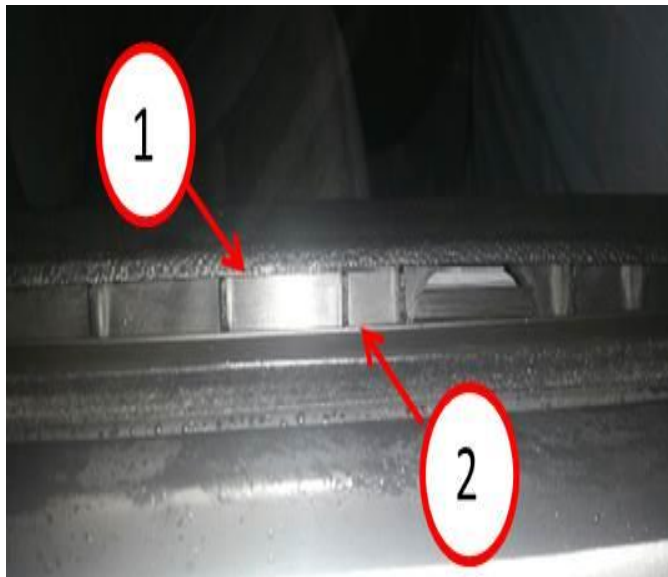
Fig. 2 Door Panel And Belt Line Gap

3. Are the gaps between the door panels and inner belt moldings greater than 3 mm (.11 in.) ([Fig. 2](#))?
 - a. YES >>> Continue to the Repair Procedure. Proceed to [Step #1](#).
 - b. NO >>> This bulletin does not apply. Normal diagnosis should be performed. This bulletin has been completed, use LOP (23-51-17-9A) to close the active RRT.

- 1 - Door Trim Panel
 - 2 - Inner Belt Molding
-

1. Remove the inner belt molding and replace inner belt molding(s) and door panel(s) with a gap measuring greater than 3 mm (.11 in). Refer to the detailed service procedures available in DealerCONNECT> TechCONNECT under: Service Info>23 - Body/Doors - Rear/Molding, Door Belt, Inner/Removal/Installation.
