NUMBER: 23-027-17

Rusty Water Draining From Vehicle

2016 - 2017 (ZD) Dodge Viper

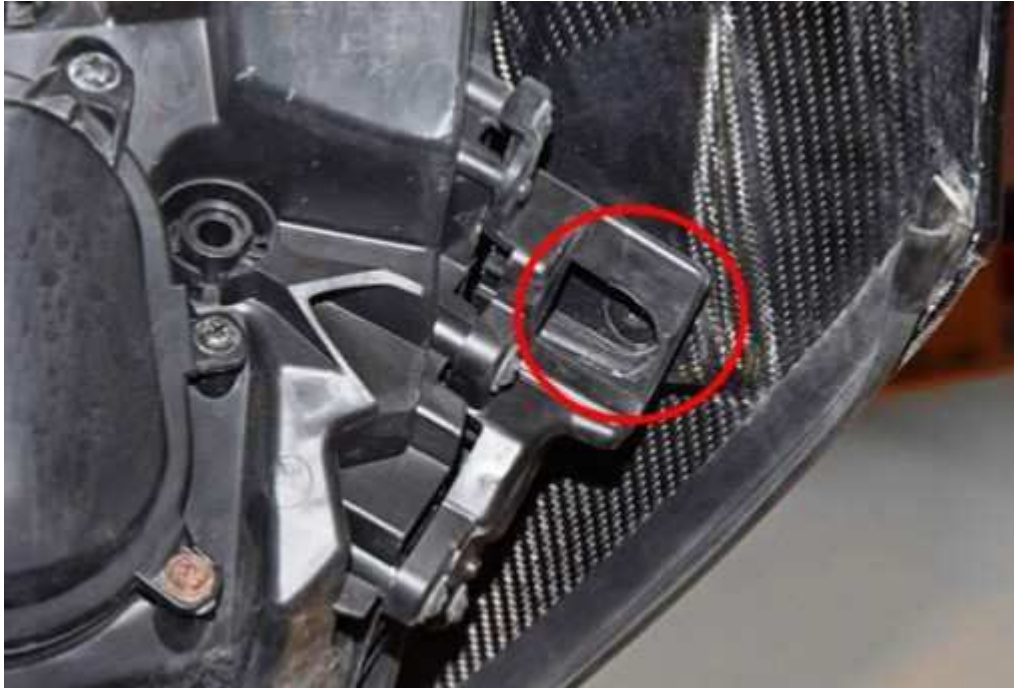
Fig. 1
Fastener Removed

Customers may describe rusty water sometimes drains down one or both sides of the vehicle after driving. This condition is caused by a headlamp fastener rusting.

1. Open the hood.
2. Remove and discard the headlamp fastener (Fig. 1) .

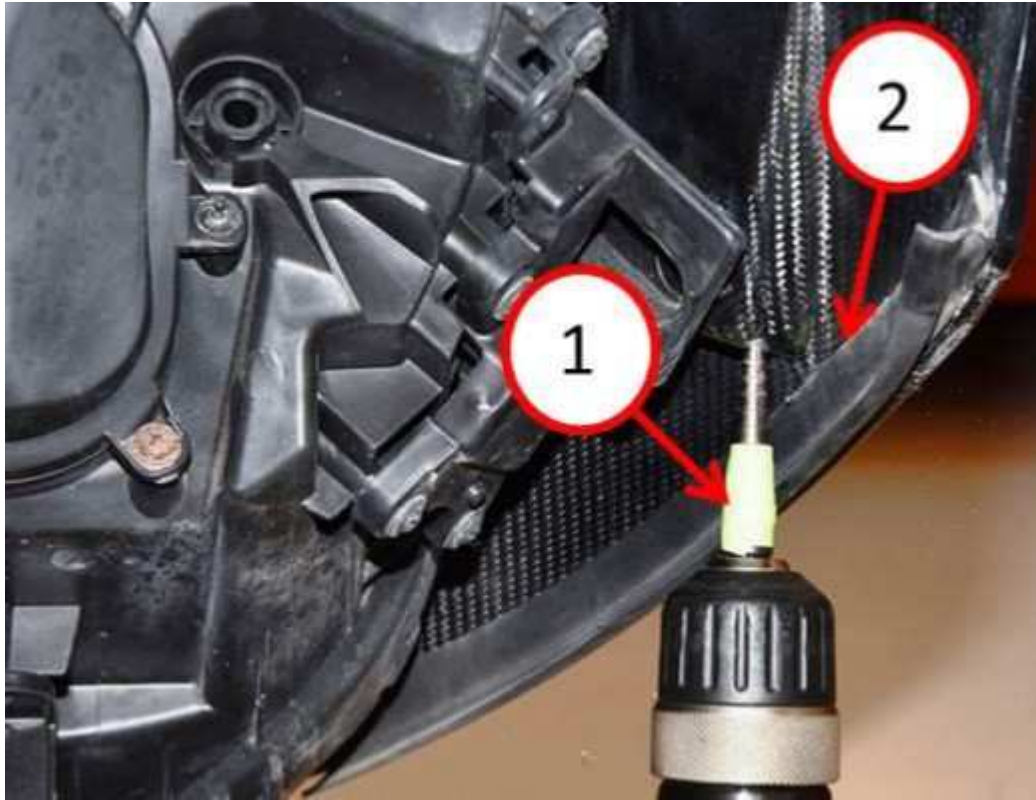
Fig. 4

Step Drill Hole And Hood Seal

- 1 - Step Bit Marked
 - 2 - Hood Seal
-

Using a #1 - 5.93 mm (0.228 in.) step drill bit marked to a 35 mm (1.3 in.) max depth, drill the pilot hole in the headlamp fastener pocket (Fig. 4) .

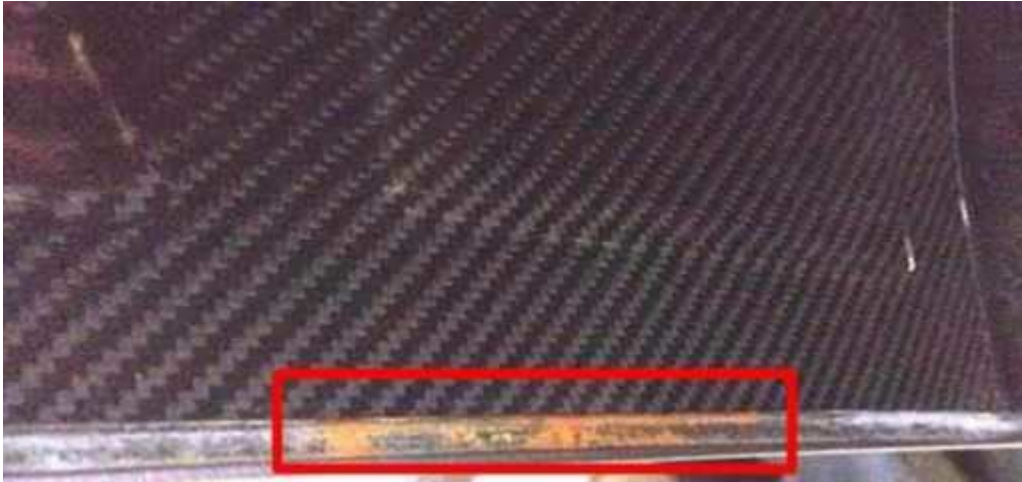
Fig. 6
Hood Liner Seam Corrosion

- Once the corrosion has been flushed out of the hood, open hood and remove the rust residue (Fig. 6) from the hood liner seam with a cleaner wax.
