NUMBER: 08-028-17 REV. A

GROUP: 08 - Electrical

DATE: July 13, 2017

RA3 and RA4 Radio Over The Air Software Updates

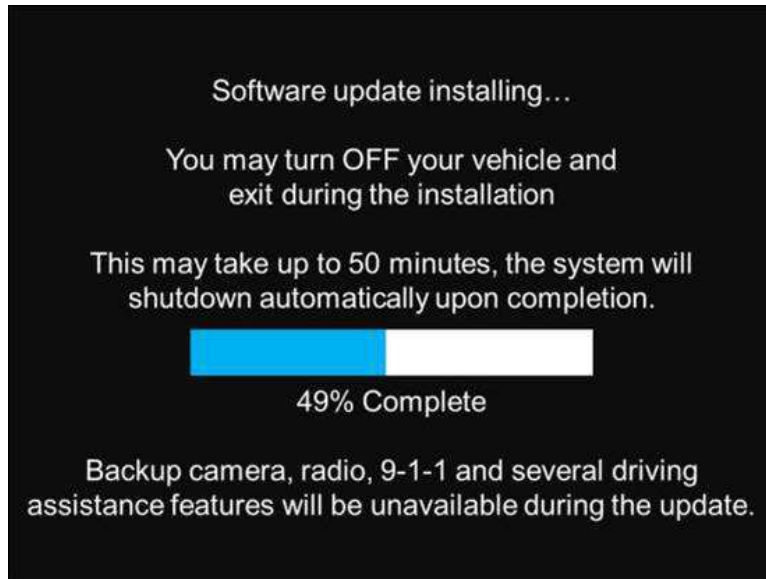
Fig. 4
Second Phase

NOTE: The second phase screen will show the completion bar go to 49% quickly and will then stay at that percentage for a longer period of time. The install is not broken/frozen.

- Once the update has reached the second phase, the message on the touchscreen will tell you that you can turn off the vehicle, exit and let the process complete on its own (Fig. 4) .

NOTE: The second phase may take up to 50 minutes to complete.
