NUMBER: 08-053-17

RA3 and RA4 Radio Enhancements

This bulletin involves inspecting and if required, updating the radio software.

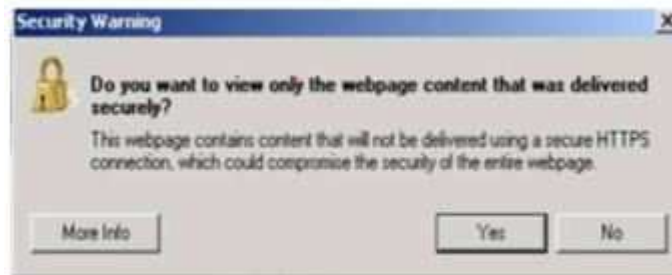
Fig. 1
Pop-up Security Message

3. If a security message appears "Do you want to view only the webpage content that was delivered securely? (Fig. 2) Press No to continue.

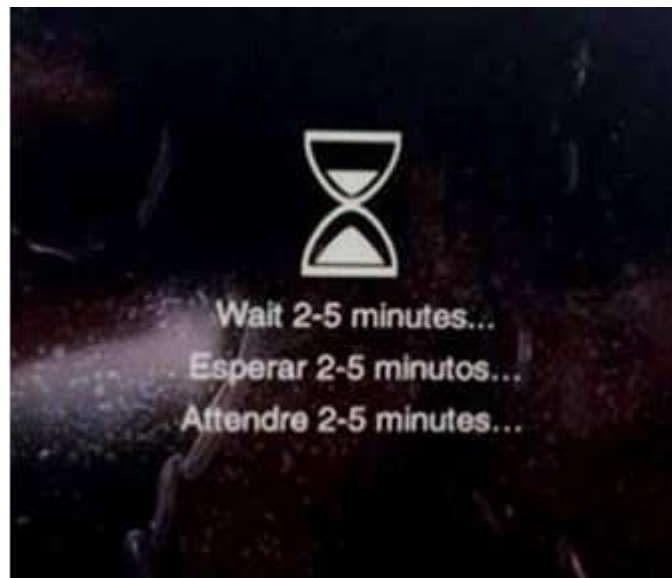
Fig. 2
Hourglass Screen

NOTE: During the update process you may see multiple hourglass screens for extended periods of time (several minutes) (Fig. 3) . DO NOT remove the USB flash drive at this time. Only remove the USB flash drive when the update has completed, when the screen displays the software levels again.
