NUMBER: 23-032-17

Left Front Door Cup Holder Insert Missing

2017 (DS) RAM 1500 Pickup

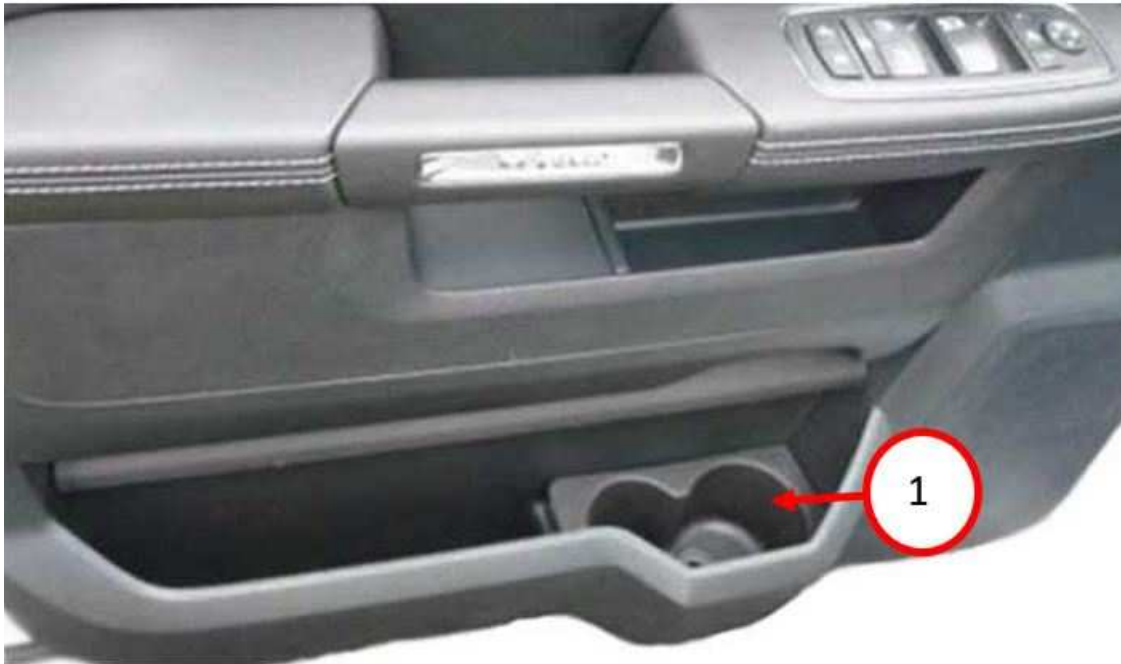
Fig. 1
Location of Driver's Door Cup Holder Insert

Some customer's may notice the cup holder insert is missing from left front door panel.

1. Install the foam cup holder insert into the interior door trim panel (Fig. 1) .
