NUMBER: 23-033-17

Paint Delamination On Front Door Panel Pull Cups (Door Pulls)

2016 (B1) Jeep Renegade

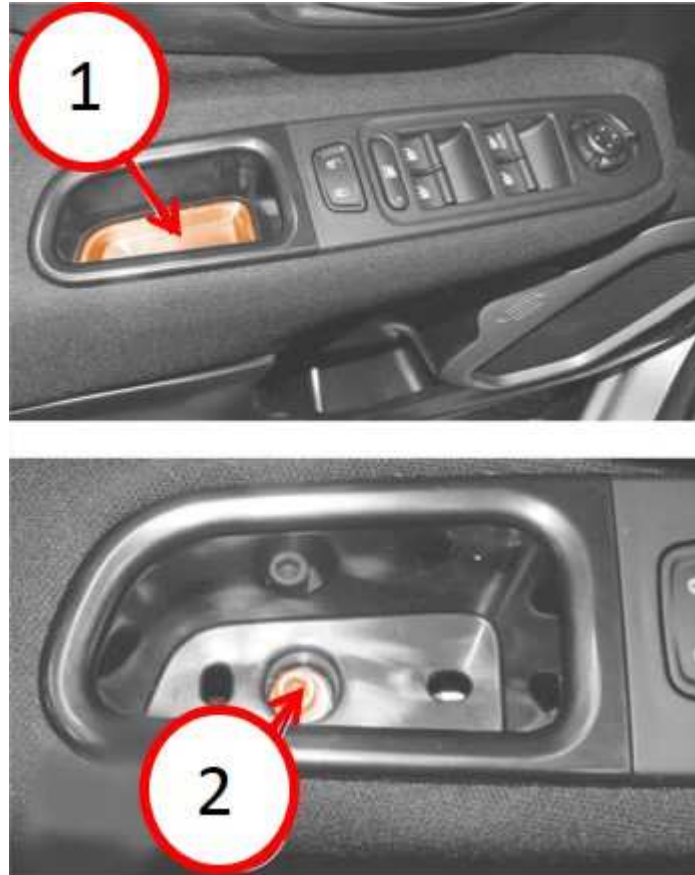
Fig. 1
Rubber Mat and Pull Cup

The customer may describe paint peeling on the left, right, or both front door panel pull cups.

1. Open the door.
2. Remove the pull cup rubber mat (Fig. 1) from the pull cup.
3. Remove the screw holding the pull cup to the door panel (Fig. 1) .

4. Remove and discard the pull cup from the door panel.
5. Install the new pull cup on the door panel.
6. Install the screw on the pull cup. Tighten screw securely.
7. Install the pull cup rubber mat on the pull cup.
8. Close the door.
