NUMBER: 23-035-17

Right Rear Door Rattle

2017 (KL) Jeep Cherokee

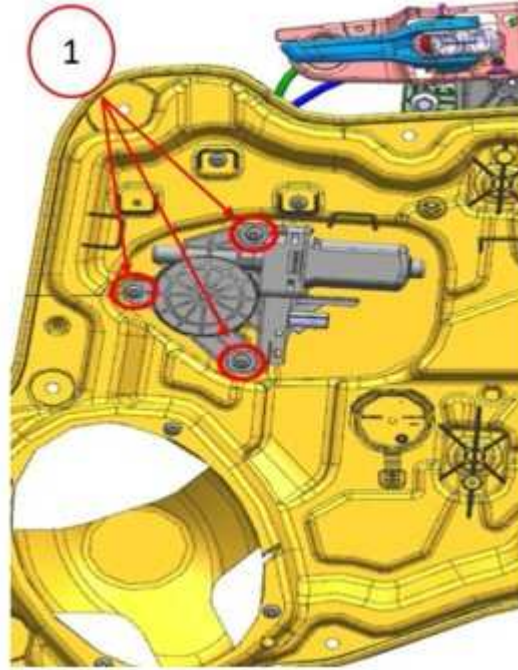
**Fig. 1
Window Motor**

The customer may describe a rattle from the right rear door and/or a clicking when raising and lowering the right rear window.

1 - Window Motor Fasteners

1. Remove the right rear door trim panel. Refer to the detailed service procedures available in DealerCONNECT> TechCONNECT under: Service Info> 23 - Body/Doors - Rear/Panel, Rear Door Trim/Removal.
2. Tighten the window motor to 3.5 N·m (31 in lbs) (Fig. 1) .
