NUMBER: 08-078-17

Outside Mirror Turn Signal is Inoperative

2014 - 2017 (VF) RAM ProMaster

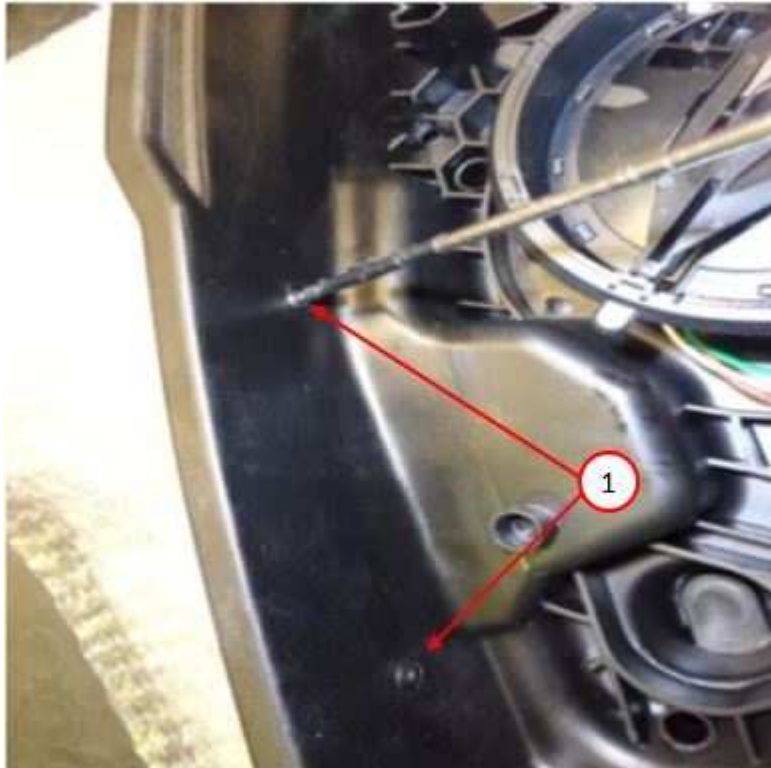
Fig. 1
Outside Mirror Assembly, With Glass Removed

Customer may experience "external lighting failure" indicator light along with accelerated blinking during turn signal operation. The inner turn signal amber lens may be distorted from excessive heat. Upon further investigation the technician may find one or more of the following Diagnostic Trouble Codes (DTCs):

1. Remove both outside mirror turn signal bulbs. Refer to the detailed service procedures available in DealerCONNECT> TechCONNECT under: 08 - Electrical/8L - Lamps and Lighting/Lamps/Lighting - Exterior/Lamp, Mirror/Removal.
2. Remove the two screws (Fig. 1) , that hold the turn signal housing/lens to the mirror assembly, discard old housing.

1 - Remove two screws

3. Install the new turn signal housing to the mirror assembly.
4. Install both outside mirror turn signal bulbs. Refer to the detailed service procedures available in DealerCONNECT> TechCONNECT under: 08 - Electrical/8L - Lamps and Lighting/Lamps/Lighting - Exterior/Lamp, Mirror/Installation.
