NUMBER: 18-072-17

P1CEA-00-Boost Side EVAP Purge System Performance, Possibly Caused by Incorrect Air Filter Box Installed

2017	(FB)	Fiat 500X
2017	(BU)	Jeep Renegade

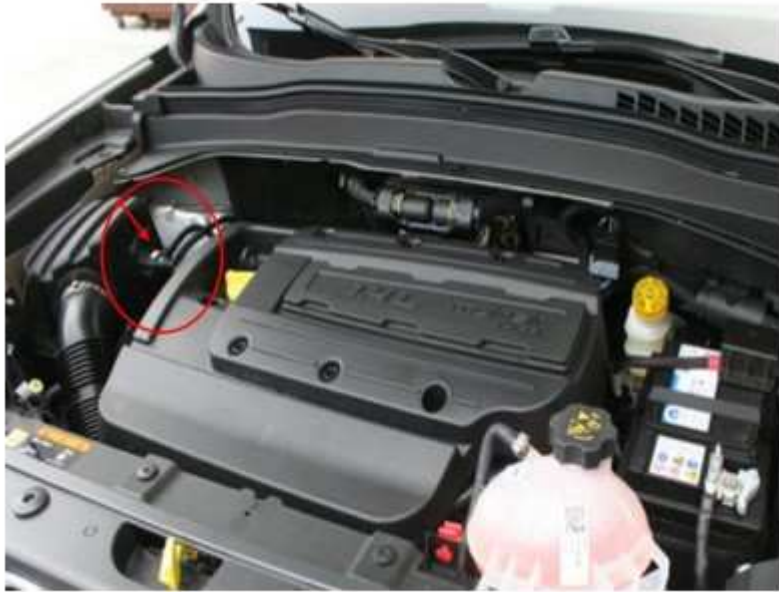
Fig. 1
Location of Dot

1. Check for a blue dot on the filter box (Fig. 1) .

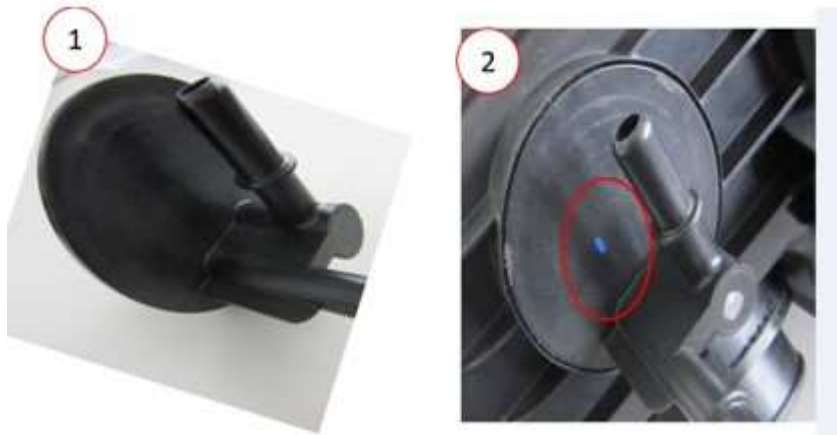
Fig. 2
Dot on Valve

2. Does the air filter box have a blue dot (Fig. 2) ?

- YES>>> Blue dot is present (Fig. 2) . Proceed to Step 1 of the repair procedure.
- NO>>> This Bulletin does not apply. Normal diagnosis of the DTC should be performed.

1 – No Dot
2 – Blue Dot

1. Remove the engine air filter box and install a new box. Refer to the detailed service procedures available in DealerCONNECT> TechCONNECT under: Service Info>09 - Engine, 1.4L I4 16V Turbo/Air Intake System/Body, Air Cleaner/Removal and Installation.
2. Clear all DTCs that may have been set prior to the repair.
