NUMBER: 08-080-17

Radio Enhancements

2017 (MP) Jeep Compass

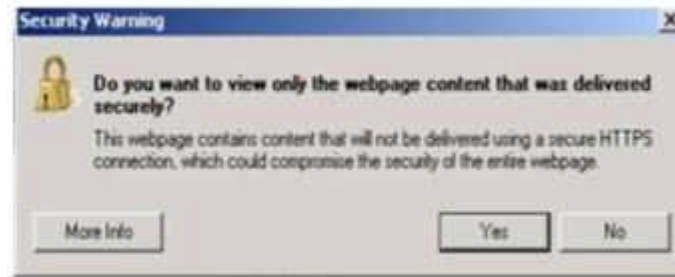
Fig. 1
Pop-up Security Message

3. If a security message appears “Do you want to view only the web page content that was delivered securely?” (Fig. 1) Press No to continue.

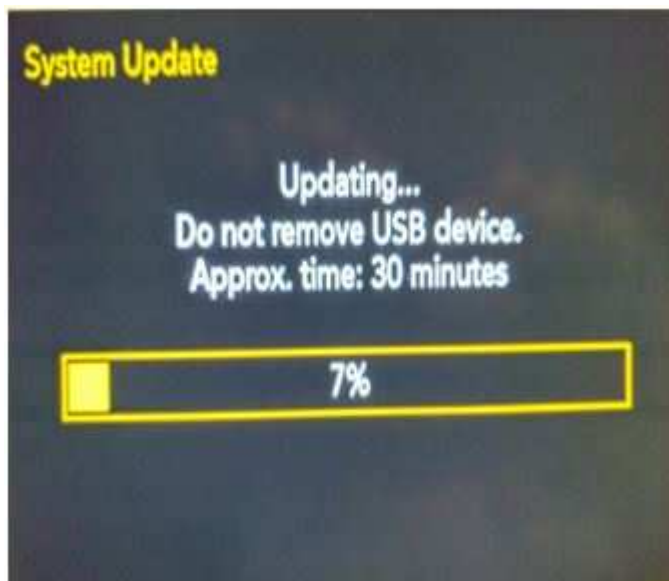
Fig. 2
Percentage Completed Screen

NOTE: There will be a variety of screens displayed throughout the update process. A black screen will appear multiple times in the process for a few minutes (Fig. 2) .

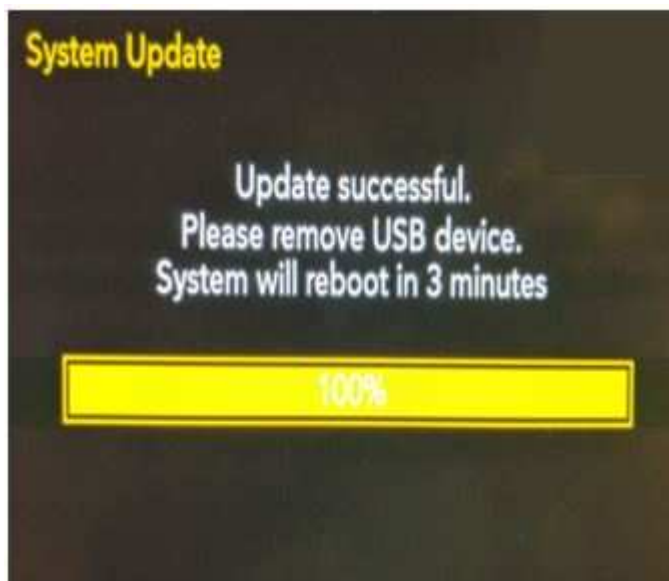
Fig. 3
Update Successful Screen

10. After the update is done the screen will display "Update successful" see (Fig. 3) .
