NUMBER: 23-036-17

Close-Out Panel Fastener Removal

This bulletin involves removing two close-out panel fasteners under the front fascia and applying an adhesive circle to cover holes.

2017 (RU) Chrysler Pacifica (PHEV)

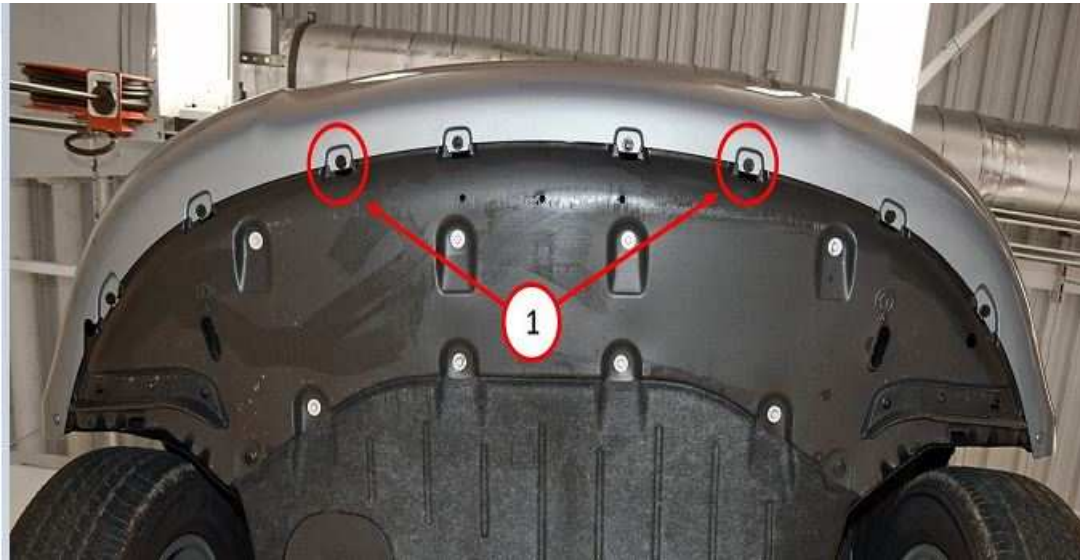
**Fig. 1****Close-Out Panel (view from under vehicle)**

The vehicle has two bolts installed during assembly in the front close-out panel that need to be removed.

Location of Close-Out Panel Bolts That Need To Be Removed

1. Remove the two close-out panel bolts (Fig. 1) .

2. Remove speed nut the original bolts threaded into.

NOTE: It is recommended to use a 90° pick to remove speed nut.
