NUMBER: 08-082-17

Auxiliary Fuel Tank, Low Fuel Indicator Will Not Turn On

2014 - 2015 (FF) Fiat 500

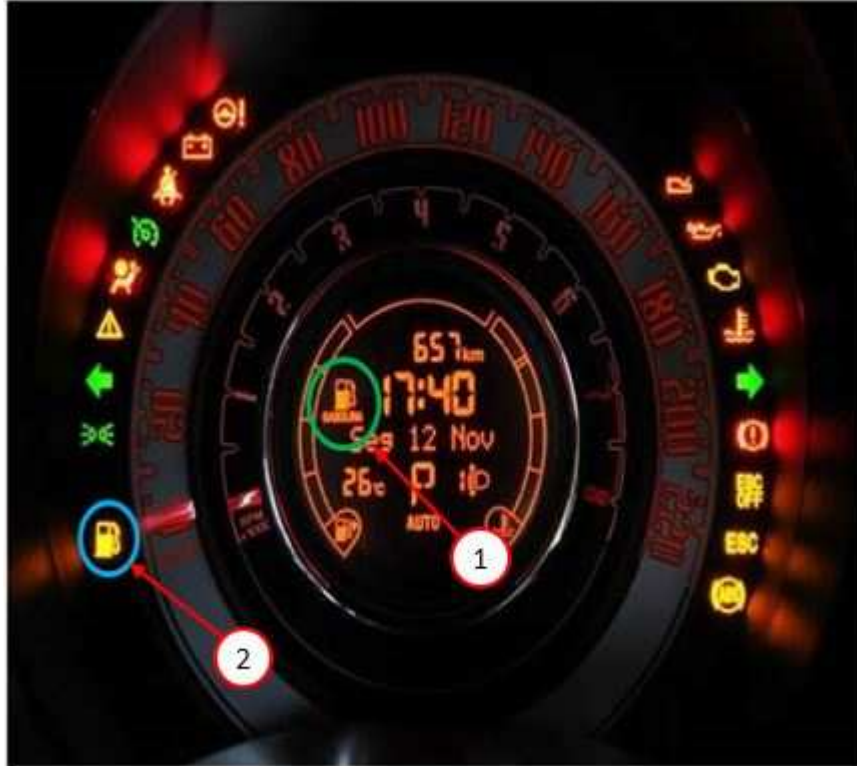
Fig. 1
Low Fuel Indicators

Customers may notice when the auxiliary fuel tank is empty, the auxiliary low fuel indication doesn't turn on, see (Fig. 1) .

- 1 - Auxiliary Tank Low Fuel Indicator
2 - Main Tank Low Fuel Indicator

1. Using wiTECH, perform the following procedures, "Restore Vehicle Configuration" and "Proxi Alignment". These procedures are available under the 'Diagnostic Procedures' tab found on the home, 'Vehicle View', page of wiTECH.
2. Turn off the ignition, disconnect the scan tool, open and close the driver's door and let all of the modules go to sleep, this should only take one minute.
3. Turn on the ignition and reconnect the scan tool.
4. Clear all DTCs that may have been set, when performing the "Restore Vehicle Configuration" and "Proxi Alignment" procedures.
