NUMBER: 08-083-17

Overhead DVD Player Does Not Play or Is Inoperative

2017 (RU) Chrysler Pacifica

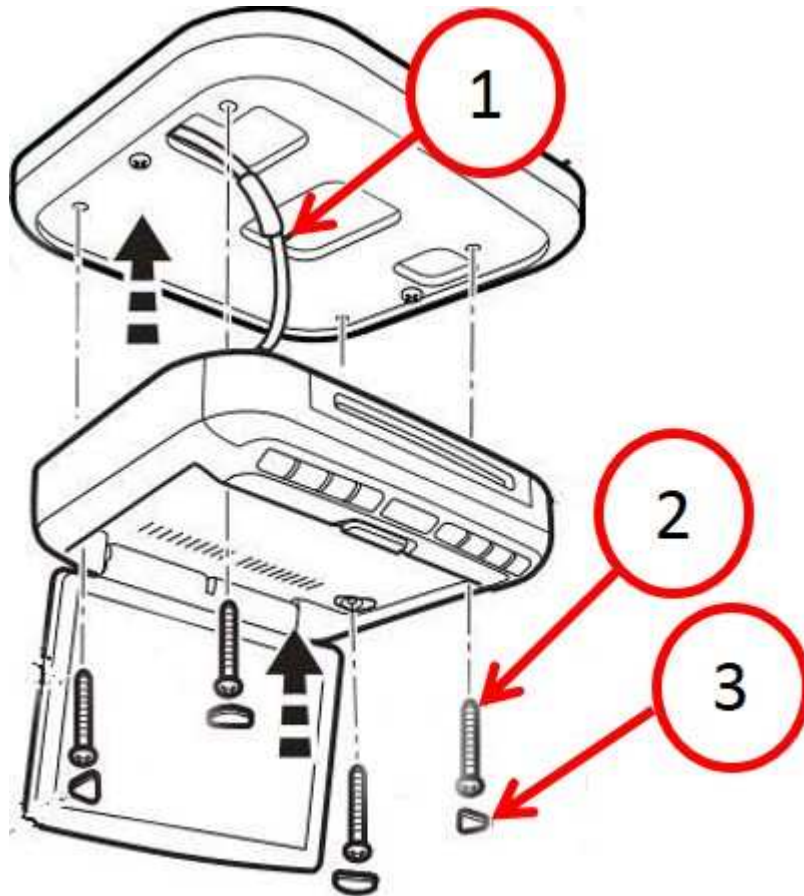
Fig. 1
Harness, Screws and Caps

- 1 - Electrical Connector Harness
 - 2 - Screws
 - 3 - Caps
-

1. Open the overhead DVD player screen.
2. Remove four triangular plastic screw caps (Fig. 1) .
3. Remove four retaining screws, disconnect the electrical connector and remove the overhead DVD player (Fig. 1) .

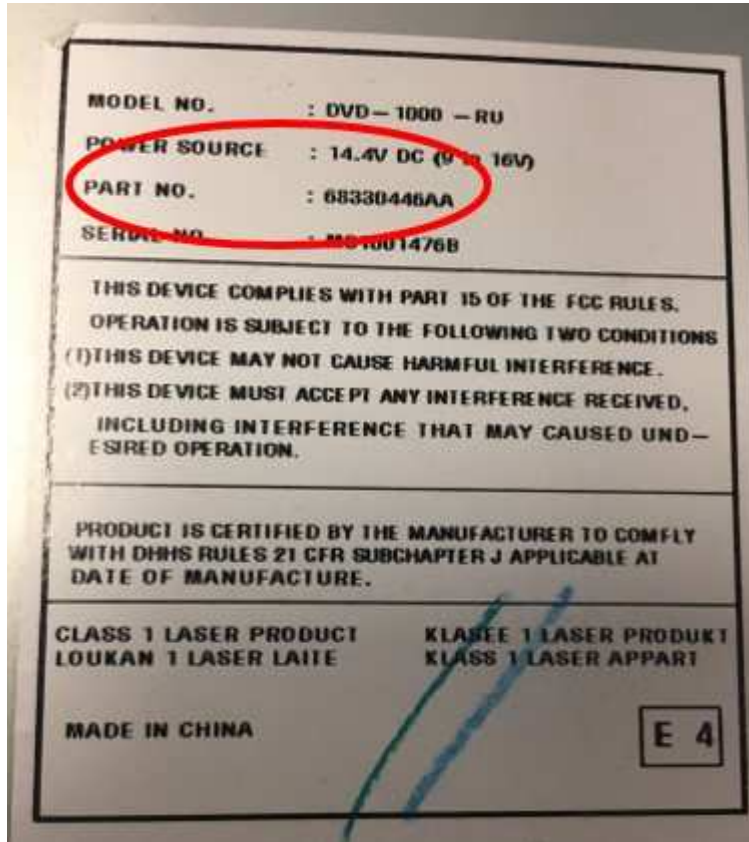
Fig. 2

4. Check the DVD player part number on the back of the player (Fig. 2) . Is the part #68330446AA?
 - a. YES>>> Continue to the Repair Procedure. Proceed to Step 1.
 - b. NO>>> This bulletin does not apply. Further diagnosis is required, use LOP (08-99-17-92) to close the bulletin.

68330446AA Part Number - Replace Overhead DVD Entertainment System

1. Replace the Overhead DVD Entertainment system. Ensure that all instructions included in the Mopar Accessory kit (#82215177AD) are followed during the repair.
