NUMBER: 08-101-17

GROUP: 08 - Electrical

UAG, UCG, UDG, UJG, ULG and UGG Radio Enhancements

This bulletin involves updating the radio with the latest available software.

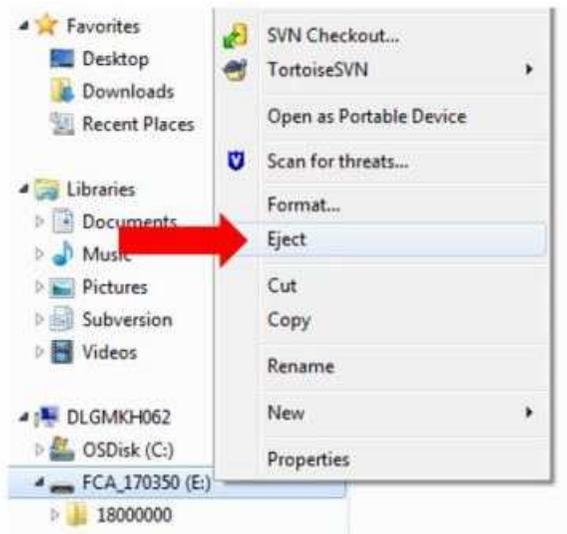
Fig. 6
Ejecting The USB Flash Drive

- 10. **CAUTION! Eject the USB flash drive properly from your PC. Failure to eject the USB flash drive properly may result in an improper file byte size and cause the update to not fully download.**

Perform the following steps to properly eject the USB flash drive (Fig. 6) :

- a. Right click on the location of the USB flash drive.
- b. Click “Eject” to avoid data corruption.
- c. Remove the USB flash drive from the PC.

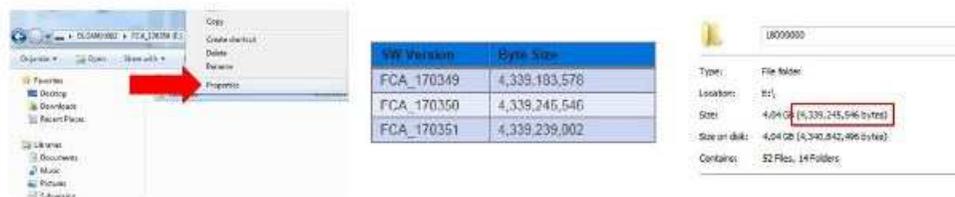
Fig. 8
Verifying The USB Flash Drive

NOTE: If this file size is incorrect, the radio may display an error message and a "Code 15".

- 11. Perform the following steps to verify the files properly transferred to the USB flash drive (Fig. 8) :

- a. Plug the USB back into the computer.
- b. Navigate to the root directory of the flash drive.
- c. Right-click “18000000” and select “Properties”.
- d. Verify the 18000000 folder byte size is **(4,339,245,546 bytes)**.
