Technical Journal

Difficulty to add/program remote key, XC90 T8

| REF NO: TJ 31698.2.0 | ISSUING DEPARTMENT: Technical Service | CAR MARKET: United States and Canada | |

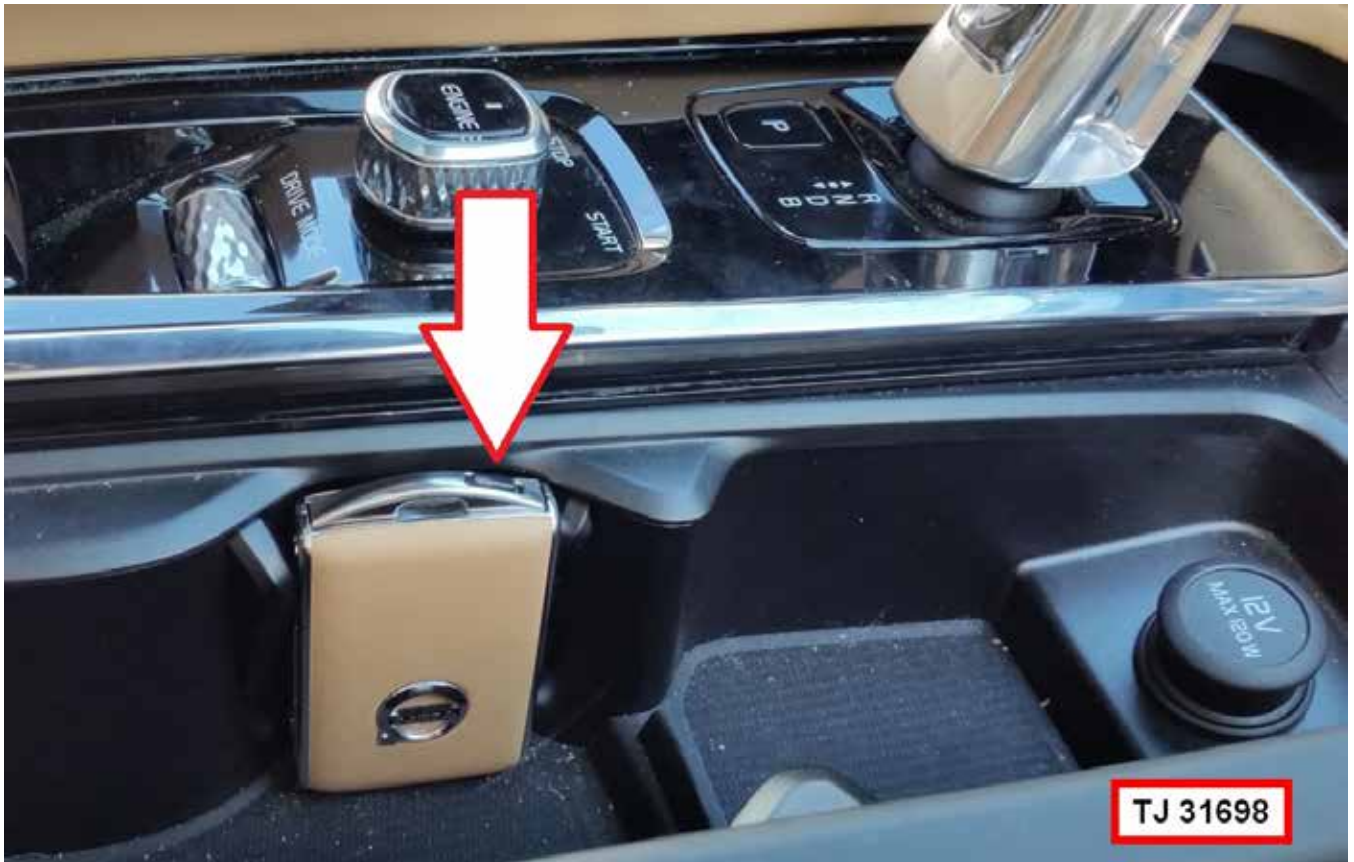
*If experiencing difficulties programming remote keys to an XC90 T8 vehicle, please follow the advice under Service.

1. Download the “**Keyless vehicle key application**” software.
2. When prompted, place the key to be programmed in the cup holder according to picture [TJ 31698.jpg](#).
Note! The slider button shall point upwards and to the front of the car.
3. Before clicking the “**Start Programming**” button, remove power from the SRS by removing fuse **BF52** in EJB (15/49) and fuse **DF26** in RJB (15/5).
4. Program all keys as intended.
5. Re-insert the SRS fuses, and end the key programming session by clicking on the “**Close**” button.
6. If the SRS warning light is still lit after VIDA has erased the DTC’s, then go to “**Software**” tab -> “**Advanced Test**” and click on the “**Reset**” button, and erase the DTC’s afterwards.
