# **Technical Journal**

### Workaround to improve software download success

REF NO: TJ 31862.1.0	ISSUING DEPARTMENT: Technical Service	CAR MARKET: United States and Canada		
3 US 7	PARTNER: 7510 Volvo Car USA	ISSUE DATE: 2017-07-06	STATUS DATE: 2017-07-06	
FUNC GROUP: 3000	FUNC DESC: electric power supply; lighting; instrum	Page	1 of 3

### **Technical Journal 31862.1.0**

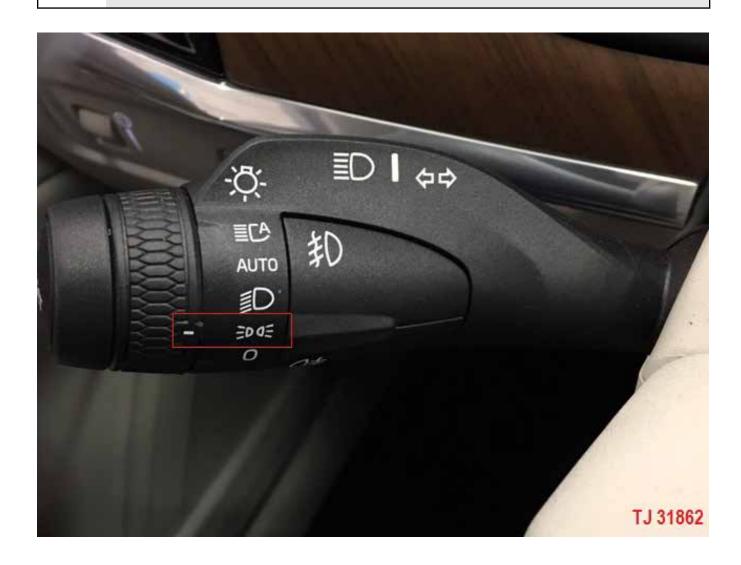
After a software download, it may happen that the car is going into "deep-sleep" directly after the software has been downloaded.

This is due to communication issue between VCM and CEM after a reset is sent to the car.

To prevent car from going into "deep-sleep", switch on the parking lamps prior to start of the software download (lighting stalk position "2" - see attachment).

This will make the car stay "awake" and all scripts will be run, and confirmation of the download will be sent to the central servers.

NOTE: DO NOT FORGET TO SWITCH OFF THE PARKING LIGHTS AFTER DOWNLOADING IS COMPLETED! HAVING THE LIGHTS ON WILL CAUSE BATTERY DRAIN. BE SURE TO SWITCH THEM TO OFF OR AUTO DEPENDING ON CUSTOMER'S SETTING BEFOREHAND
