Technical Journal

“No Navigation Activated” Message in Sensus Navigation tile

REF NO: TJ 32929.1.4	ISSUING DEPARTMENT: Technical Service	CAR MARKET: United States and Canada	
PARTNER: 3 US 7510 Volvo Car USA		ISSUE DATE: 2018-06-19	STATUS DATE: 2018-06-29
FUNC GROUP: 3900	FUNC DESC: Media, navigation and communication	Page 1 of 6

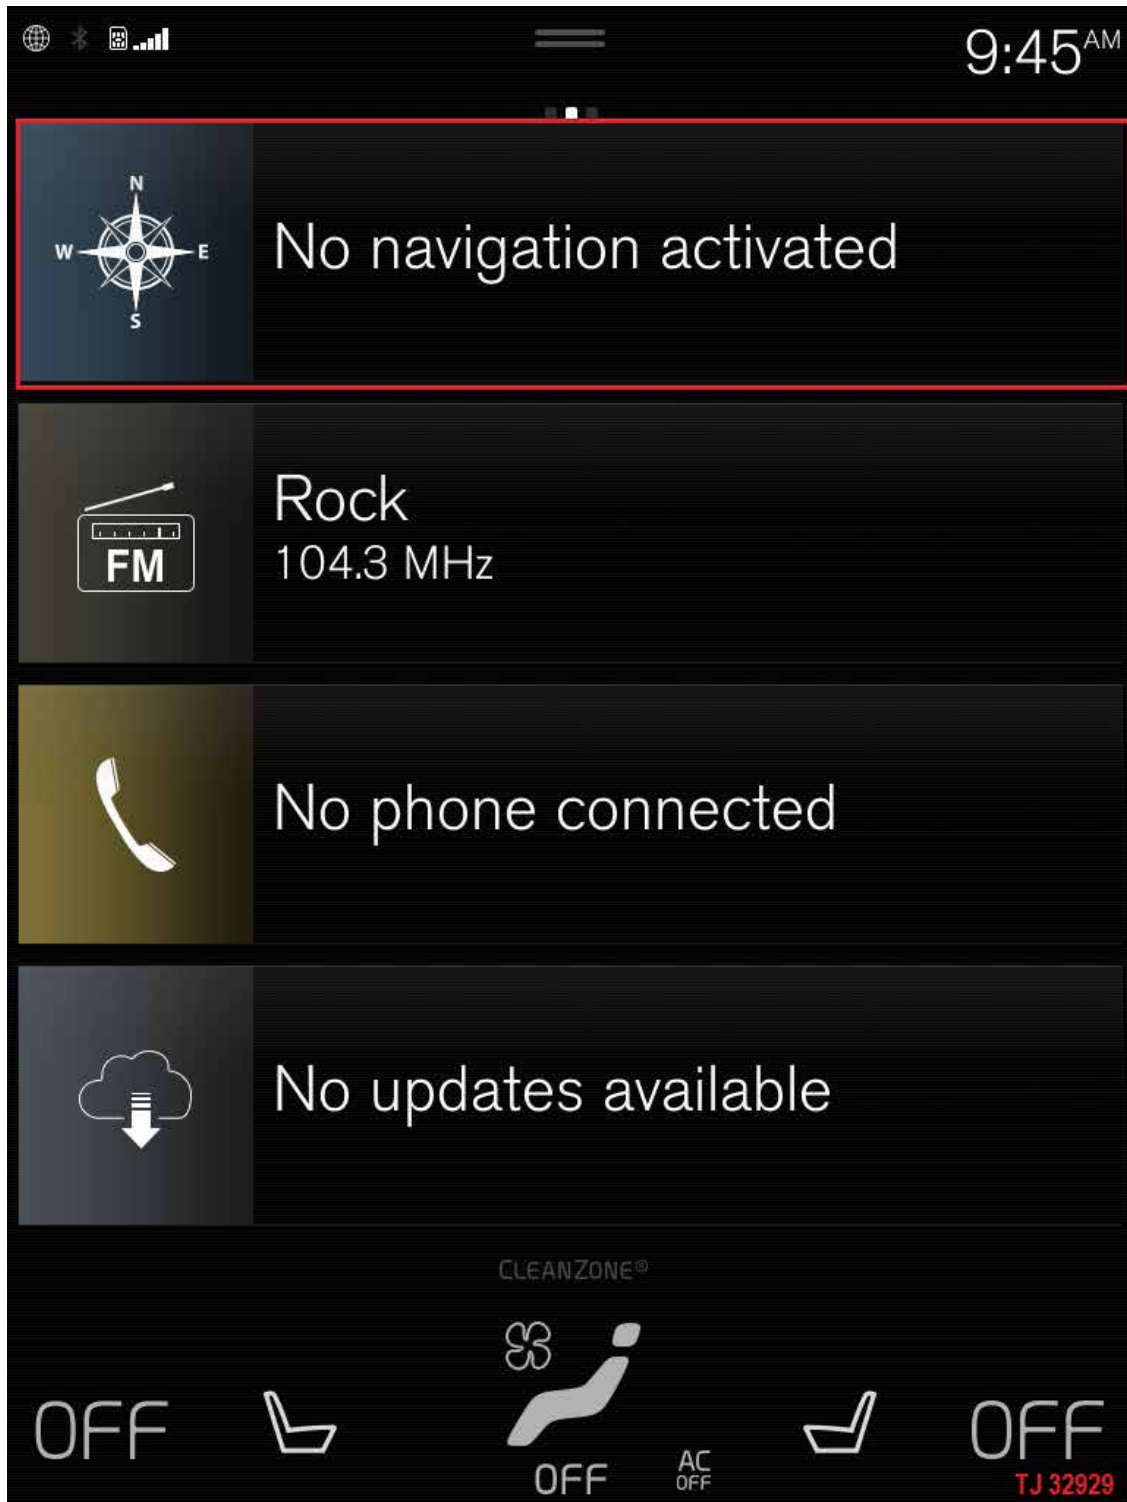
If the customer has not purchased factory navigation (Option Code 255), the message “No Navigation Activated” will be displayed in the Sensus Navigation tile (see attachment TJ 32929_1.jpg).

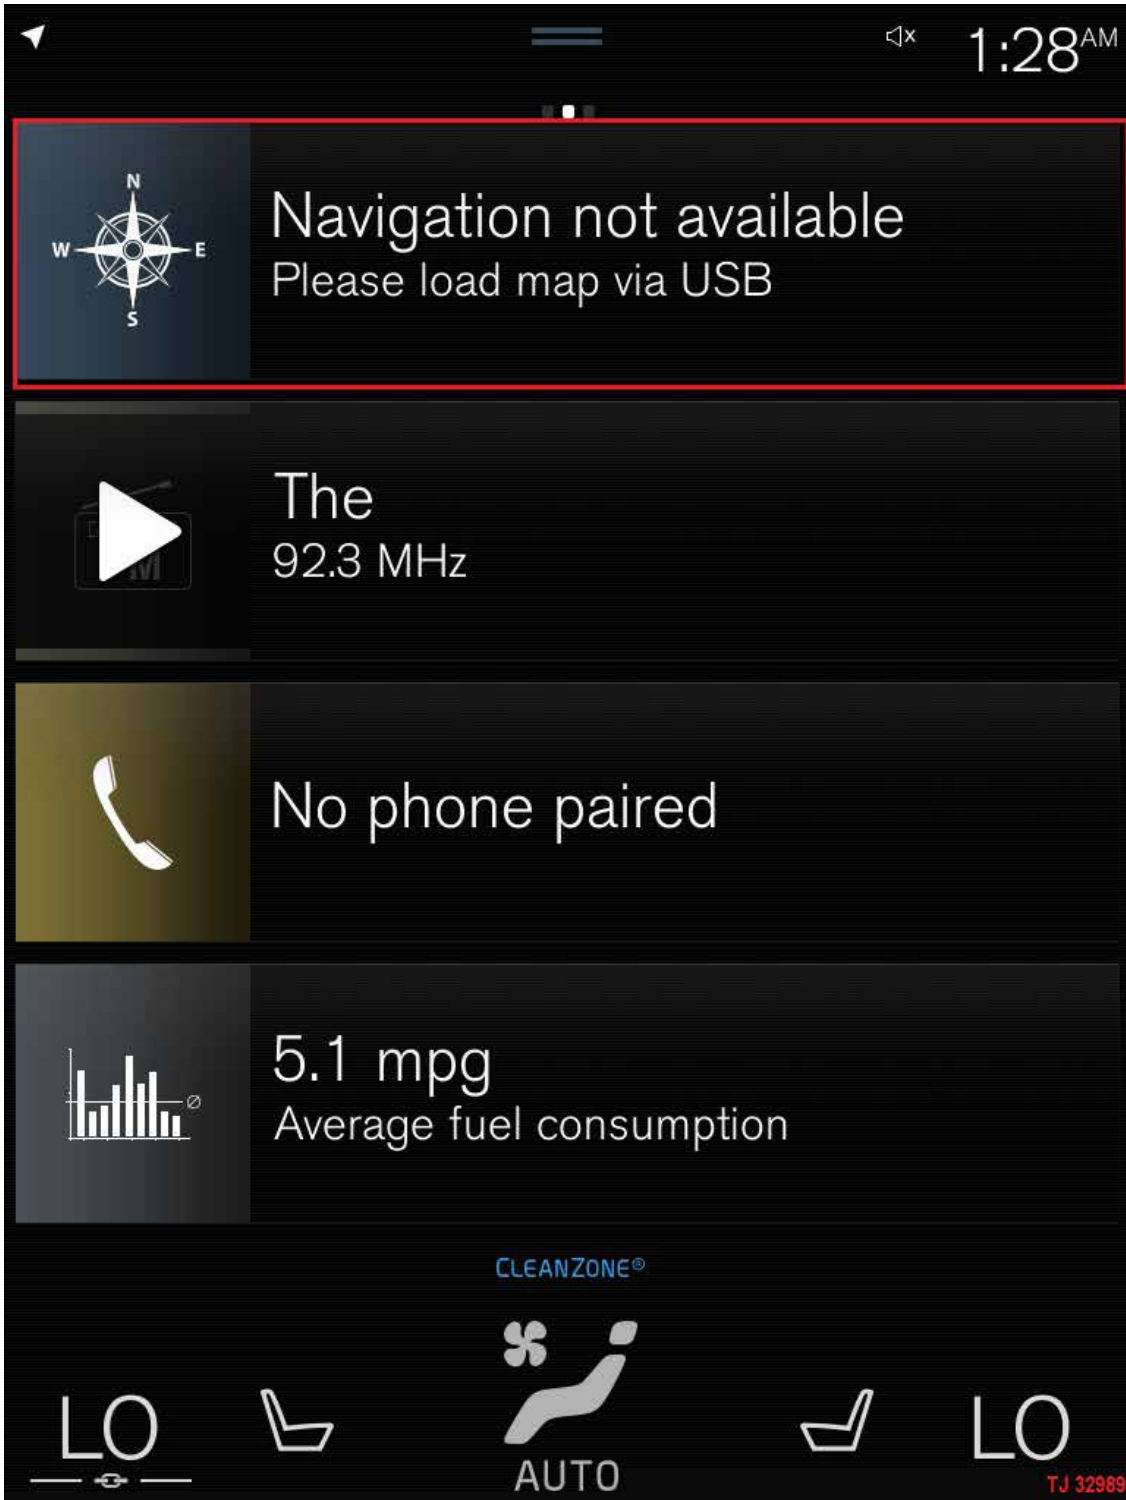
*Vehicles that *are* equipped with factory Sensus Navigation will have the message “Navigation not available, please load map via USB” displayed in the Navigation tile when the vehicle arrives from the factory (see attachment TJ 32929_Maps Not Loaded.jpg). Proceed with loading maps to the vehicle as per PDS guidelines on these vehicles.
