Subject: CLUNKING NOISE FROM REAR SUSPENSION WHEN DRIVING OVER ROAD SLOPE / BUMP	Bulletin No: 02-011/16
	Last Issued: 07/20/2016

APPLICABLE MODEL(S)/VINS

2016 MX-5 vehicles with VINs lower than JM1ND*****411025 (produced before February 4, 2016)

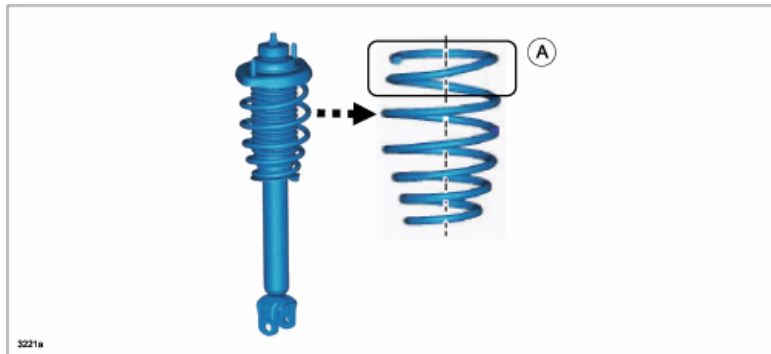
Some vehicles may exhibit a clunking noise from the rear suspensions when driving over road slopes or bumps. This concern may be caused by the top two windings of the rear shock absorber coil spring (A) interfering with one another and causing a stick-slip noise.
