Technical Service Bulletin Number

TSB170003

Fault Codes 1867 and 2962 Caused by Water Intrusion

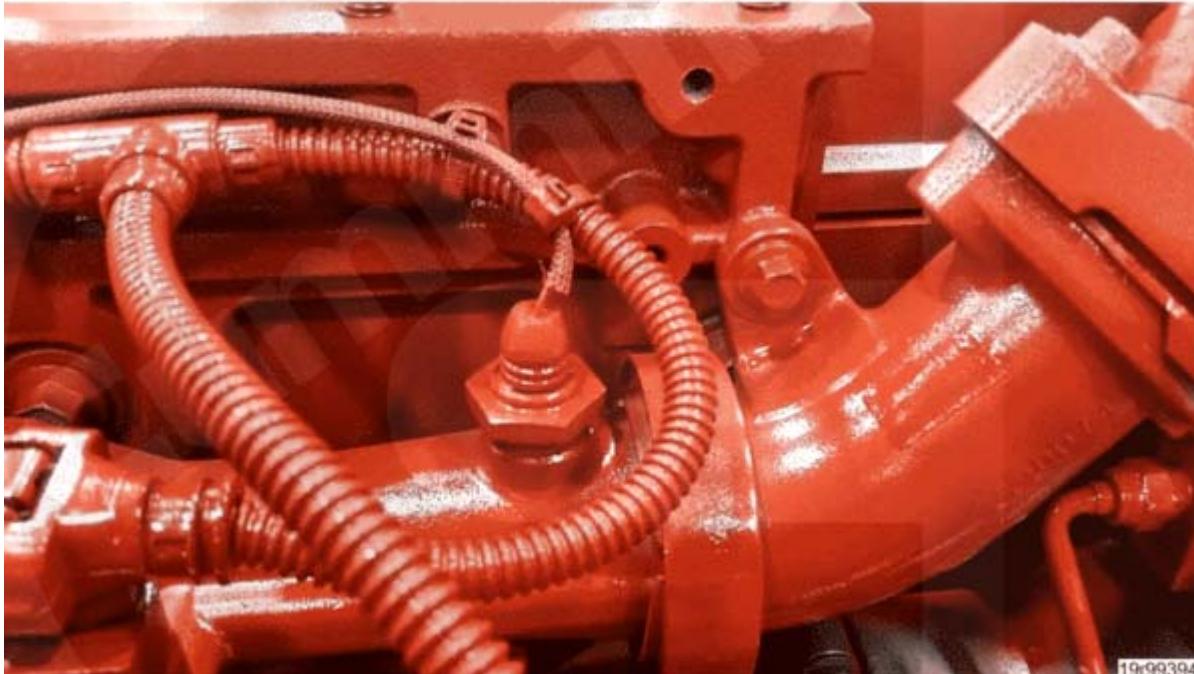
- Water intrusion caused by exhaust gas recirculation (EGR) temperature sensor water jacket distortion. EGR temperature sensor wires on select chassis were overstretched during EGR temperature sensor installation and wiring harness routing.

Figure 1, Incorrect Routing of EGR Temperature Sensor Wiring.

- If EGR temperature sensor water jacket is distorted, replace EGR temperature sensor and route the wiring harness per the Service Instructions section below.

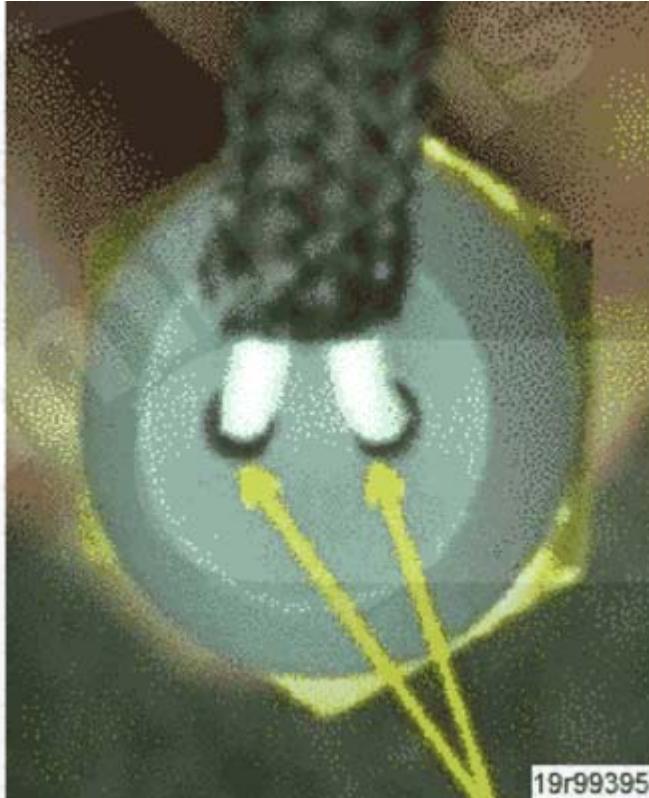
Figure 2, Normal EGR Temperature Sensor Water Jacket.

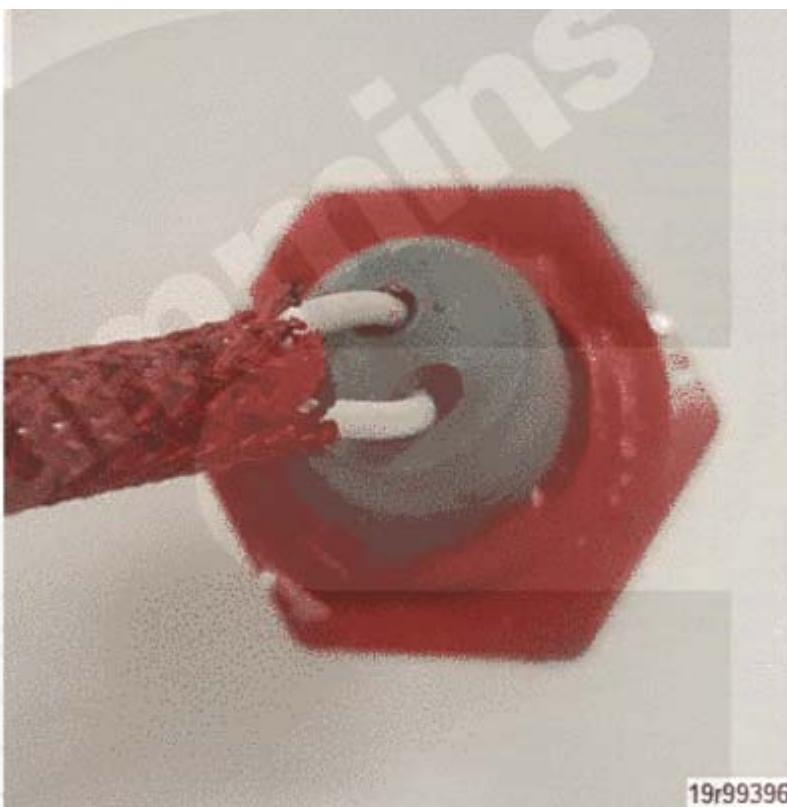
Figure 3, Distorted EGR Temperature Sensor Water Jacket.

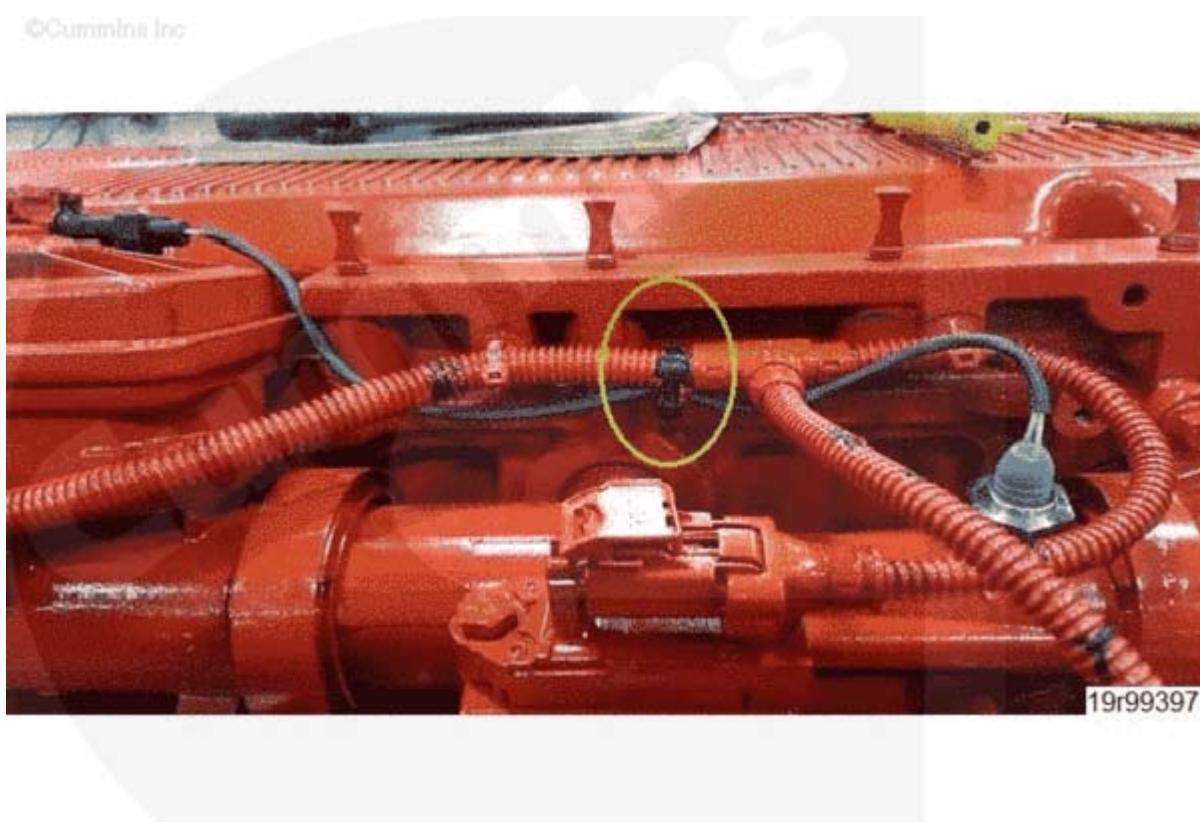
Figure 4, Correct Routing of EGR Temperature Sensor Wiring.

- Route new EGR temperature sensor wiring below wiring harness convolute, securing EGR temperature sensor wiring using **only** one ziptie as shown in Figure 4 below.
- Secure EGR temperature sensor wiring so wire leads going into EGR temperatures sensor are near vertical. See Figure 4 below.
- **Do not:**
 - Twist EGR temperature sensor wires during installation.
 - Pinch or crush EGR temperature sensor wiring or wiring harness convolute by over-tightening zip-tie.
