# Service Bulletin

17-018

# 2013–17 RDX: Judder from the Torque Converter Lock-Up Clutch After Software Update

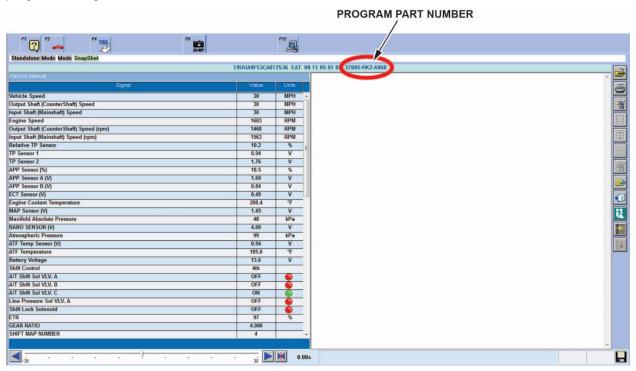
1. Connect the i-HDS, and go to the **A/T Data List**. Check to see if the software has been updated by comparing the program P/N against the table below.

If the program P/N is listed below (or later), the software has been updated. Go to step 2.
