**BUZZ/RATTLE OVER BUMPS - LEFT SIDE DEFROST VENT TRIM PANEL  
- BUILT ON OR BEFORE 13-FEB-2017**

**TSB 17-0024**

2017 MKC

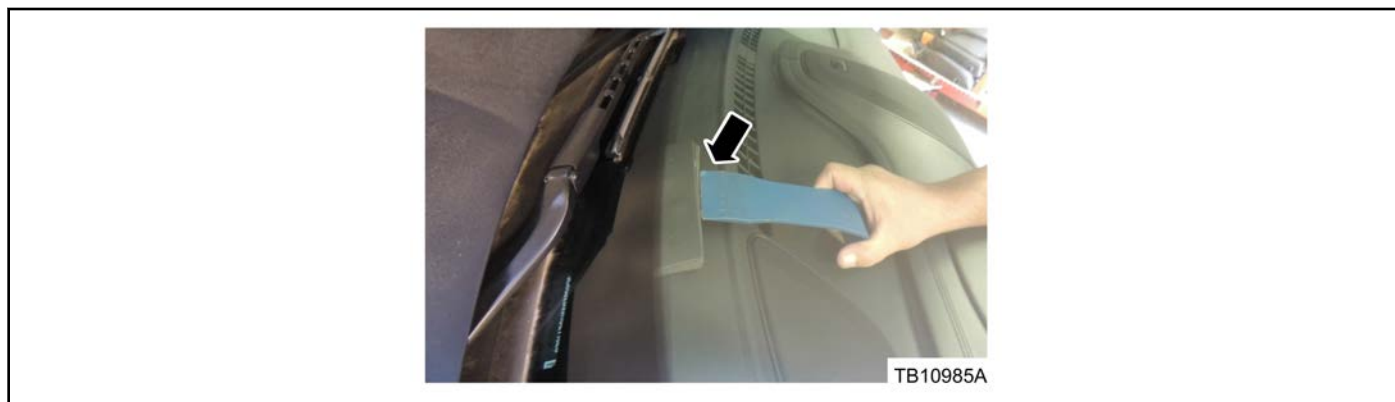
Figure 1 - Article 17-0024

Some 2017 MKC vehicles built on or before 13-Feb-2017 may exhibit a buzz/rattle noise from the left side of the defrost vent trim panel. This is due to the defrost vent trim panel contacting bare metal on top of the cowl close to the windshield.

1. With the protective backing removed, uniformly stack together 3 pieces of polyvinyl chloride (PVC) soft foam tape 164-R4901 from the Rotunda Squeak and Rattle repair Kit 164-R4900 to create a thickness of 9.5 mm (3/8 inch).
2. Insert the PVC soft foam tape lengthwise at the forward edge of the defrost trim panel where it meets the windshield. Position the tape between left speaker grille and defrost air vent opening as shown. (Figure 1)

3. Using a plastic trim tool wedge the piece of PVC soft foam tape down until the tape is no longer visible and will not show in the reflection of the glass.
